Lake Victoria: Falling Water Levels Concern for Growing Population

Population Growth Around Lake Victoria

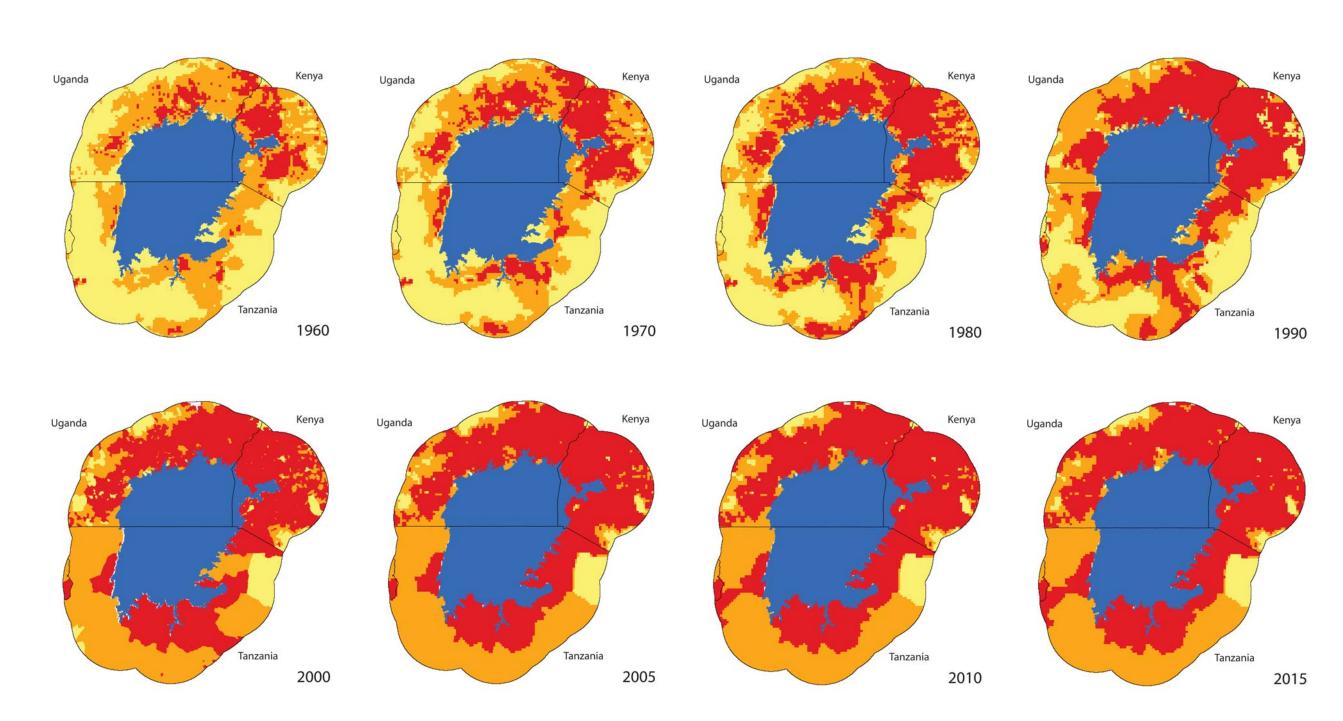
Population growth around Lake Victoria is significantly higher than the rest of Africa. During each decade, population growth within a 100-km buffer zone around the lake outpaced the continental average. This reflects growing dependency and pressure on lake's resources. The population change is graphically represented below. The graphics also show projected growth for 2010 and 2015.

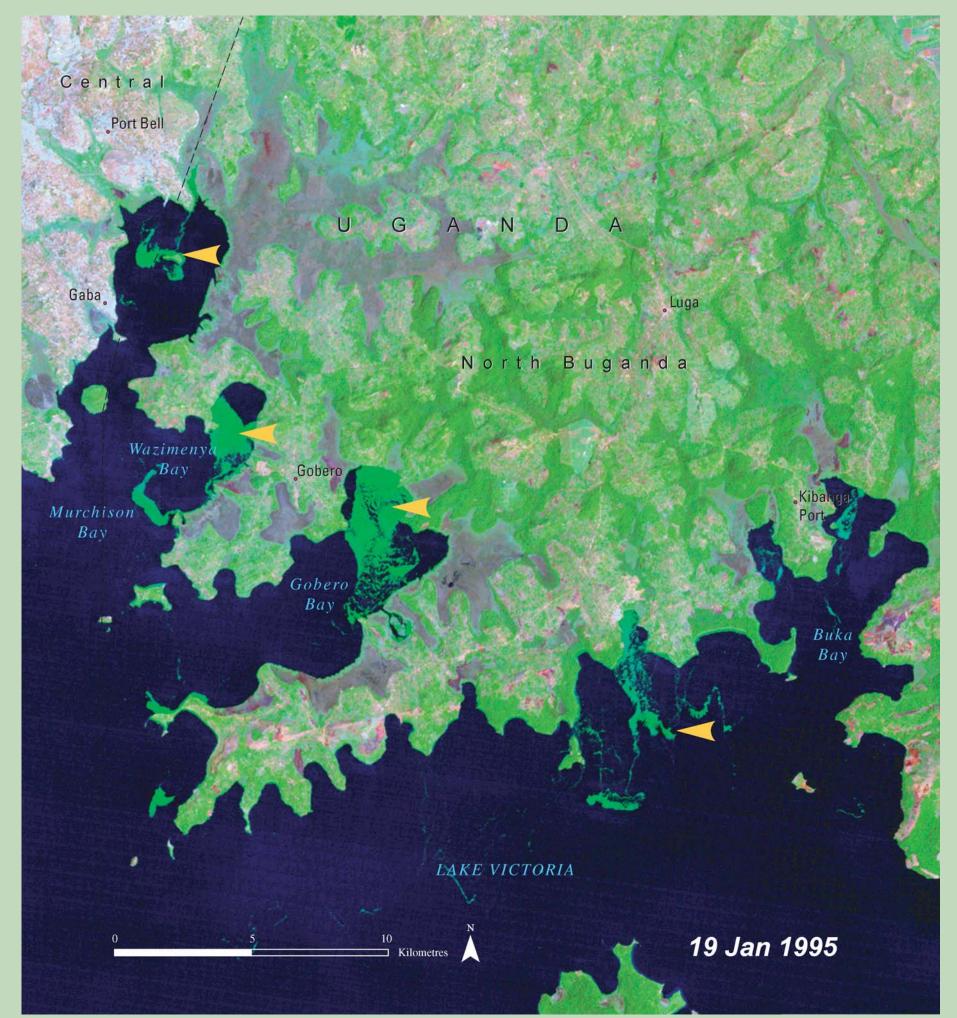
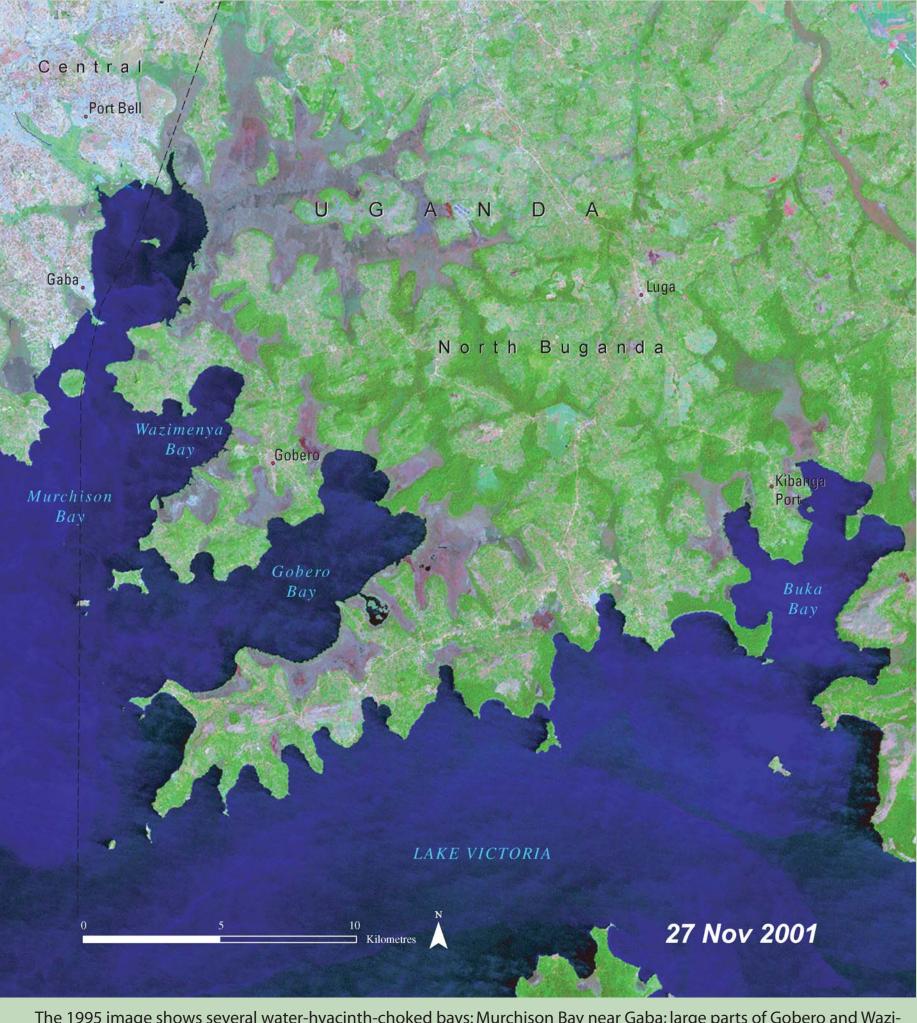
The 1995 image shows several water-hyacinth-choked bays: Murchison Bay near Gaba; large parts of Gobero and Wazimenya Bays; an area outside Buka Bay; and near Kibanga Port (yellow arrows). Initially, water hyacinth was controlled by hand, with the plants being manually removed from the lake. But re-growth quickly occurred. A more recent control measure has been the careful introduction of natural insect predators of water hyacinth. As the 2001 image shows, this approach seems to have been successful, as the floating weeds have all but disappeared from all the locations noted above.

Shared by Kenya, Tanzania, and Uganda, Lake Victoria is the second largest freshwater lake in the world. The infestation of Lake Victoria by water hyacinth in the 1990s disrupted transportation and fishing, clogged water intake pipes for municipal water, and created habitat for disease-causing mosquitoes and other insects. This led to the initiation of the Lake Victoria Environmental Management Project in 1994. The focus of the Project was to combat hyacinth infestations on the lake, particularly the region bordered by Uganda, which was one of the most severely affected areas.

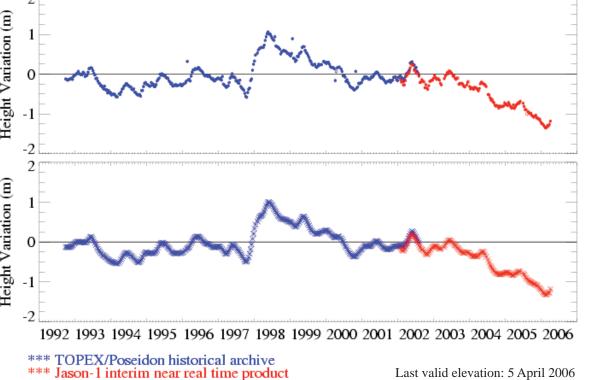
Lake Victoria Heigh Variations TOPEX 10 Year Geo-referenced 10Hz Along Track Reference 2 Lake Victoria's level variations

Lake Victoria's level variation, derived from satellite altimeter measurements, shows a negative height variation trend—even after the significant inflows of water from the 1997-98 flooding. Water levels have remained above-average for more than 40 years, but current water levels are below normal and the lowest level since September, 1961. This pattern should be of long-term concern to all the countries of East Africa, as well as those along the Nile Basin.

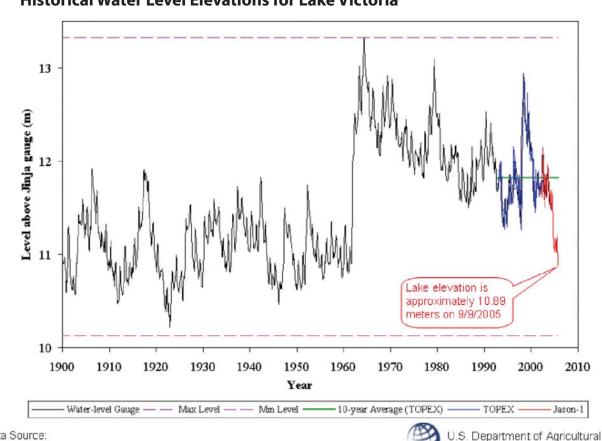
Historical Water Level Elevations for Lake Victoria

In the 105-year history of accurate measurements on the lake, water levels have fluctuated widely. In 1961 and 1962, for example, heavy rain drove water levels up by an astounding 2 metres. Since then, levels above the gauge in Jinja, Uganda, stayed above 11.9 metres (about 1 134 metres above sea level) until December 2005. Since December 2005, water levels dropped to alarmingly low levels and are not expected to stop dropping until the rains arrive (NASA 2006).

Data Source:
Historical water level gauge data from Jinja, Uganda (near Lake Victoria's outlet)
Satellite radar altimeter data from USDS/NASA/UMD at:
http://www.pecad.fas.usda.gov/cropexplorer/global_reservoir/
