Tests of FNAL GPS Coincidence Board

David E. Kraus, Gene Bender, Steve Grosland, Julia Thompson
UMSL/PITT Quarknet/RET 2003

September 4, 2003

Tests performed on the Fermilab Quarknet Board in summer 2003 at the Pitt/UMSL Quarknet/RET program are described. Problems and workarounds are discussed.

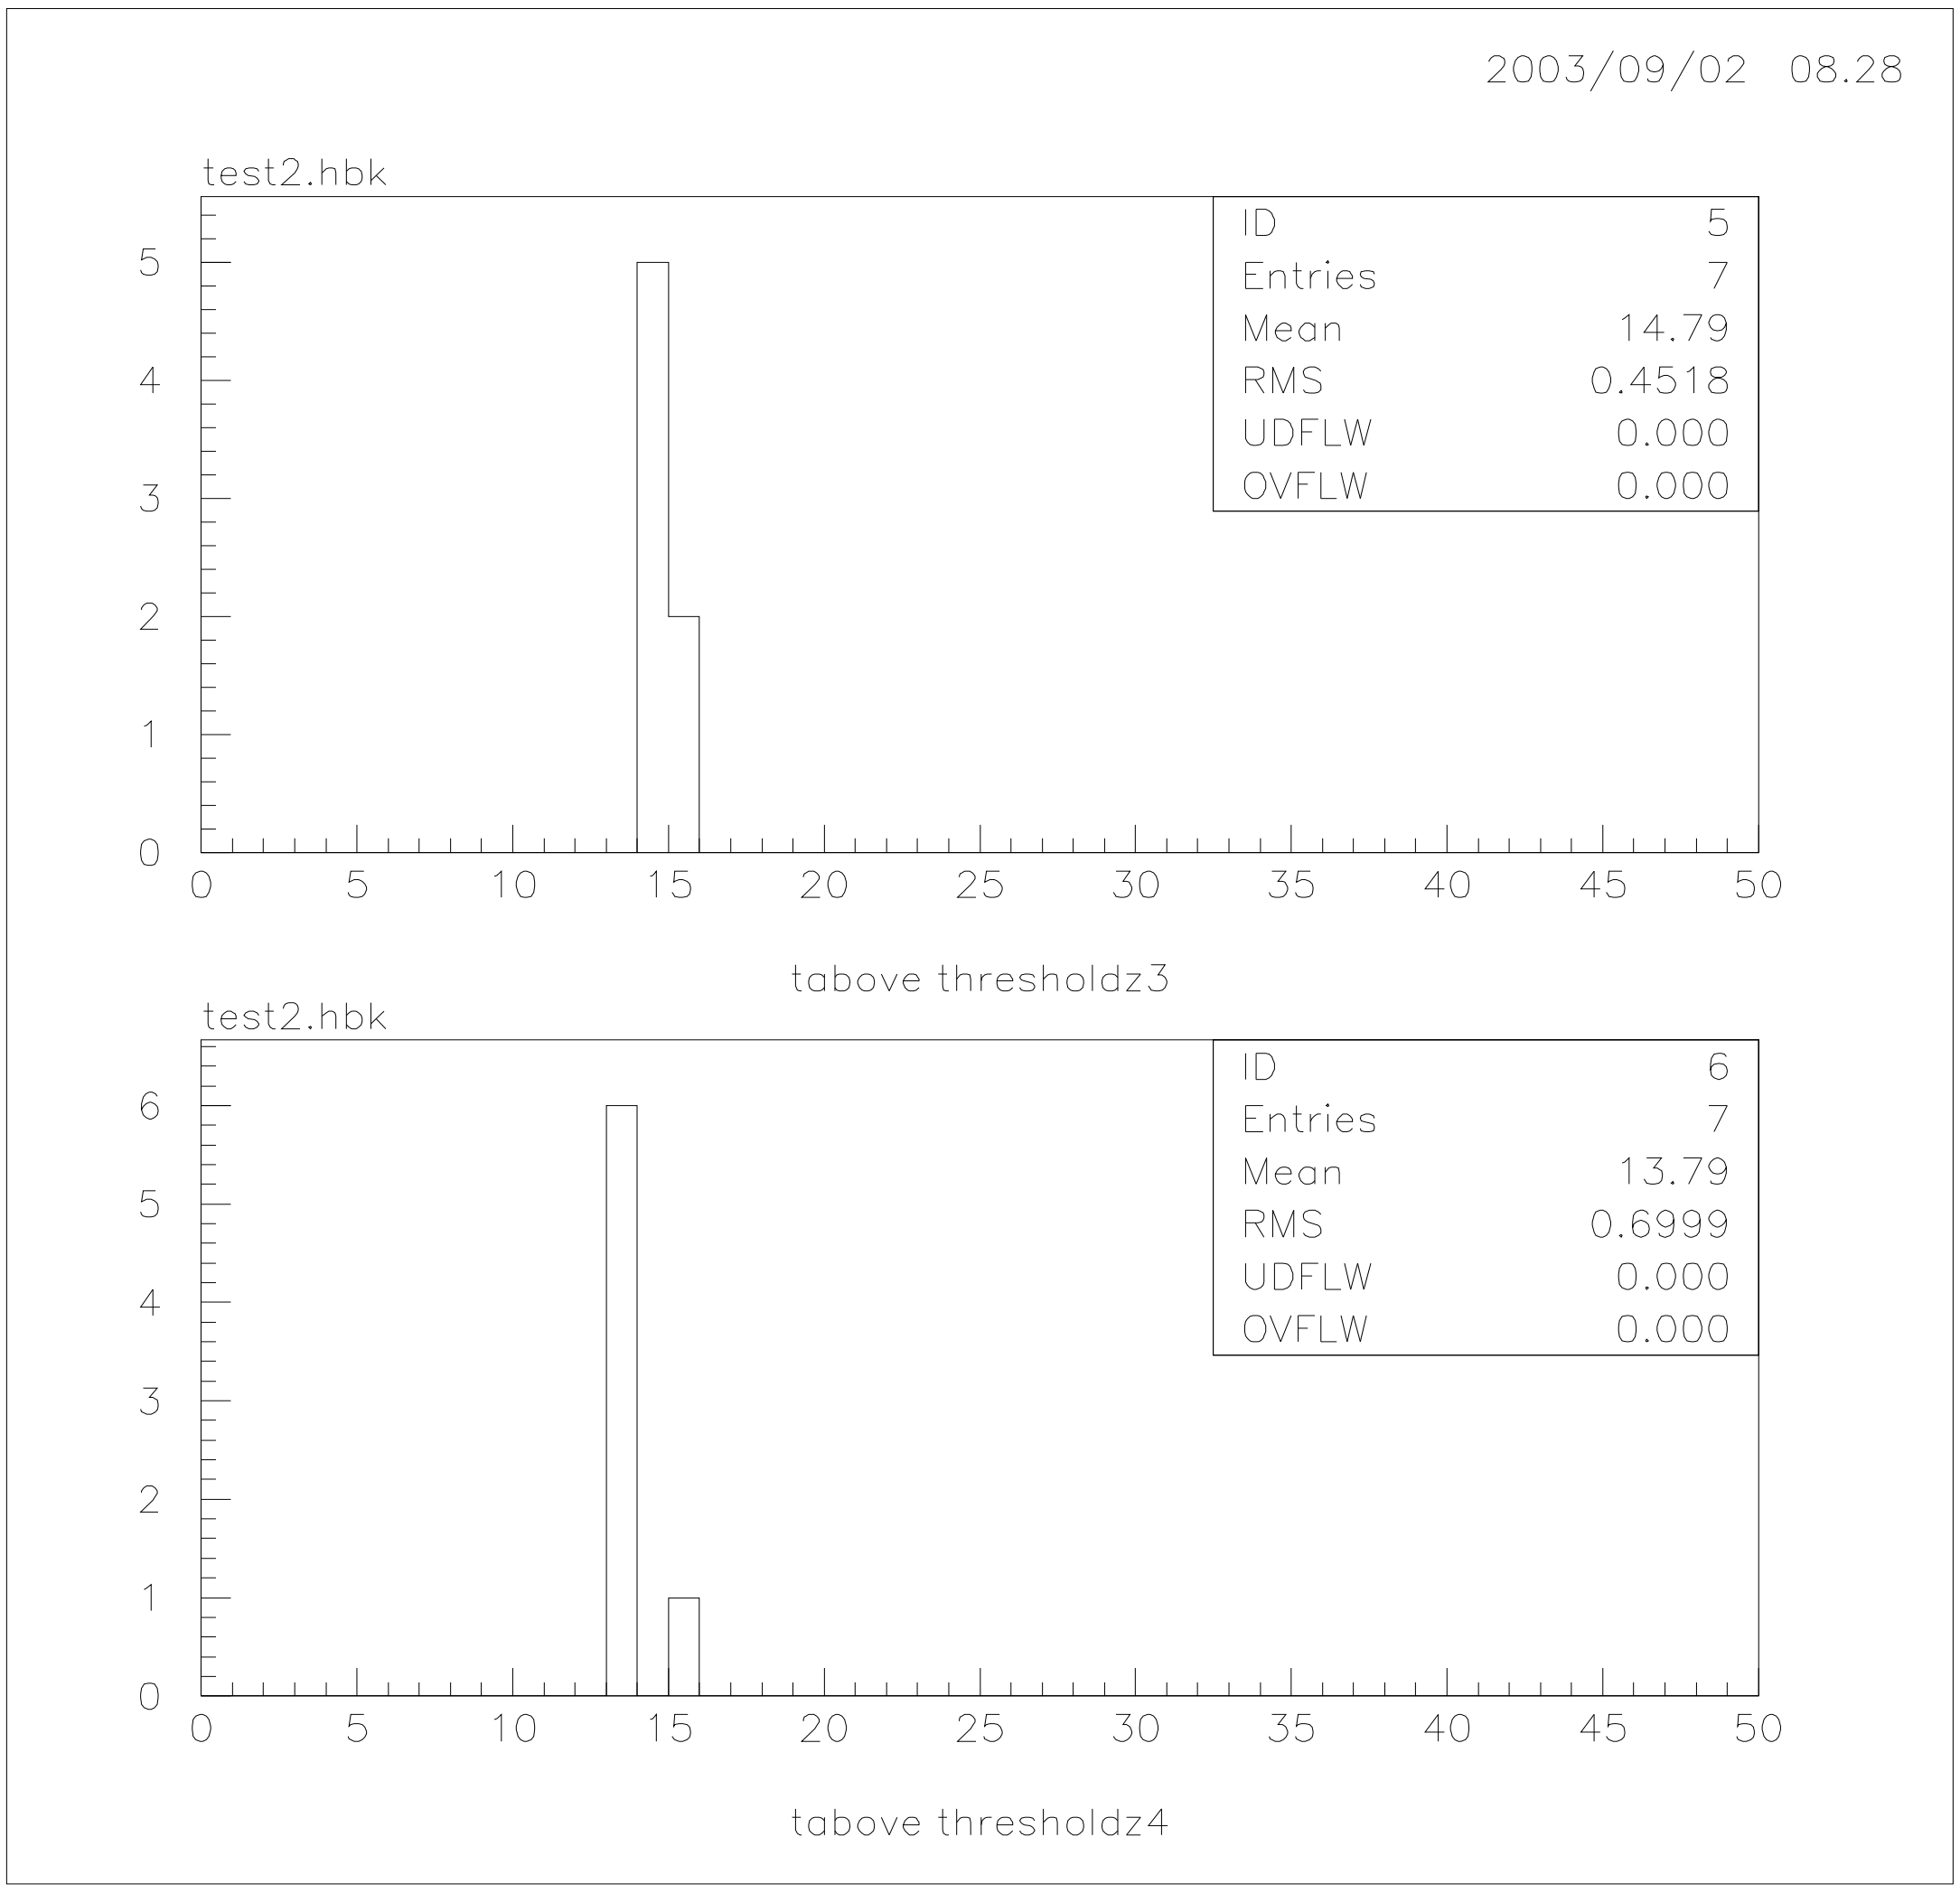
This run was used to gain familiarity with the data, and learn how to get the time above threshold for continuing events. A plot of the time above threshold (proportional to the amplitude) is shown in Figure 1. The time interval between counts of a 41.6MHz clock is approximately 25 ns. This period is further subdivided into 32 bins (so, overall timing of 25ns/32) by the time above threshold word, which takes up one byte in the record. The time seen, approximately 13 (* 25ns/32) corresponds to the width of the input pulse used.

Figure 1: Time above threshold for channels 3 and 4

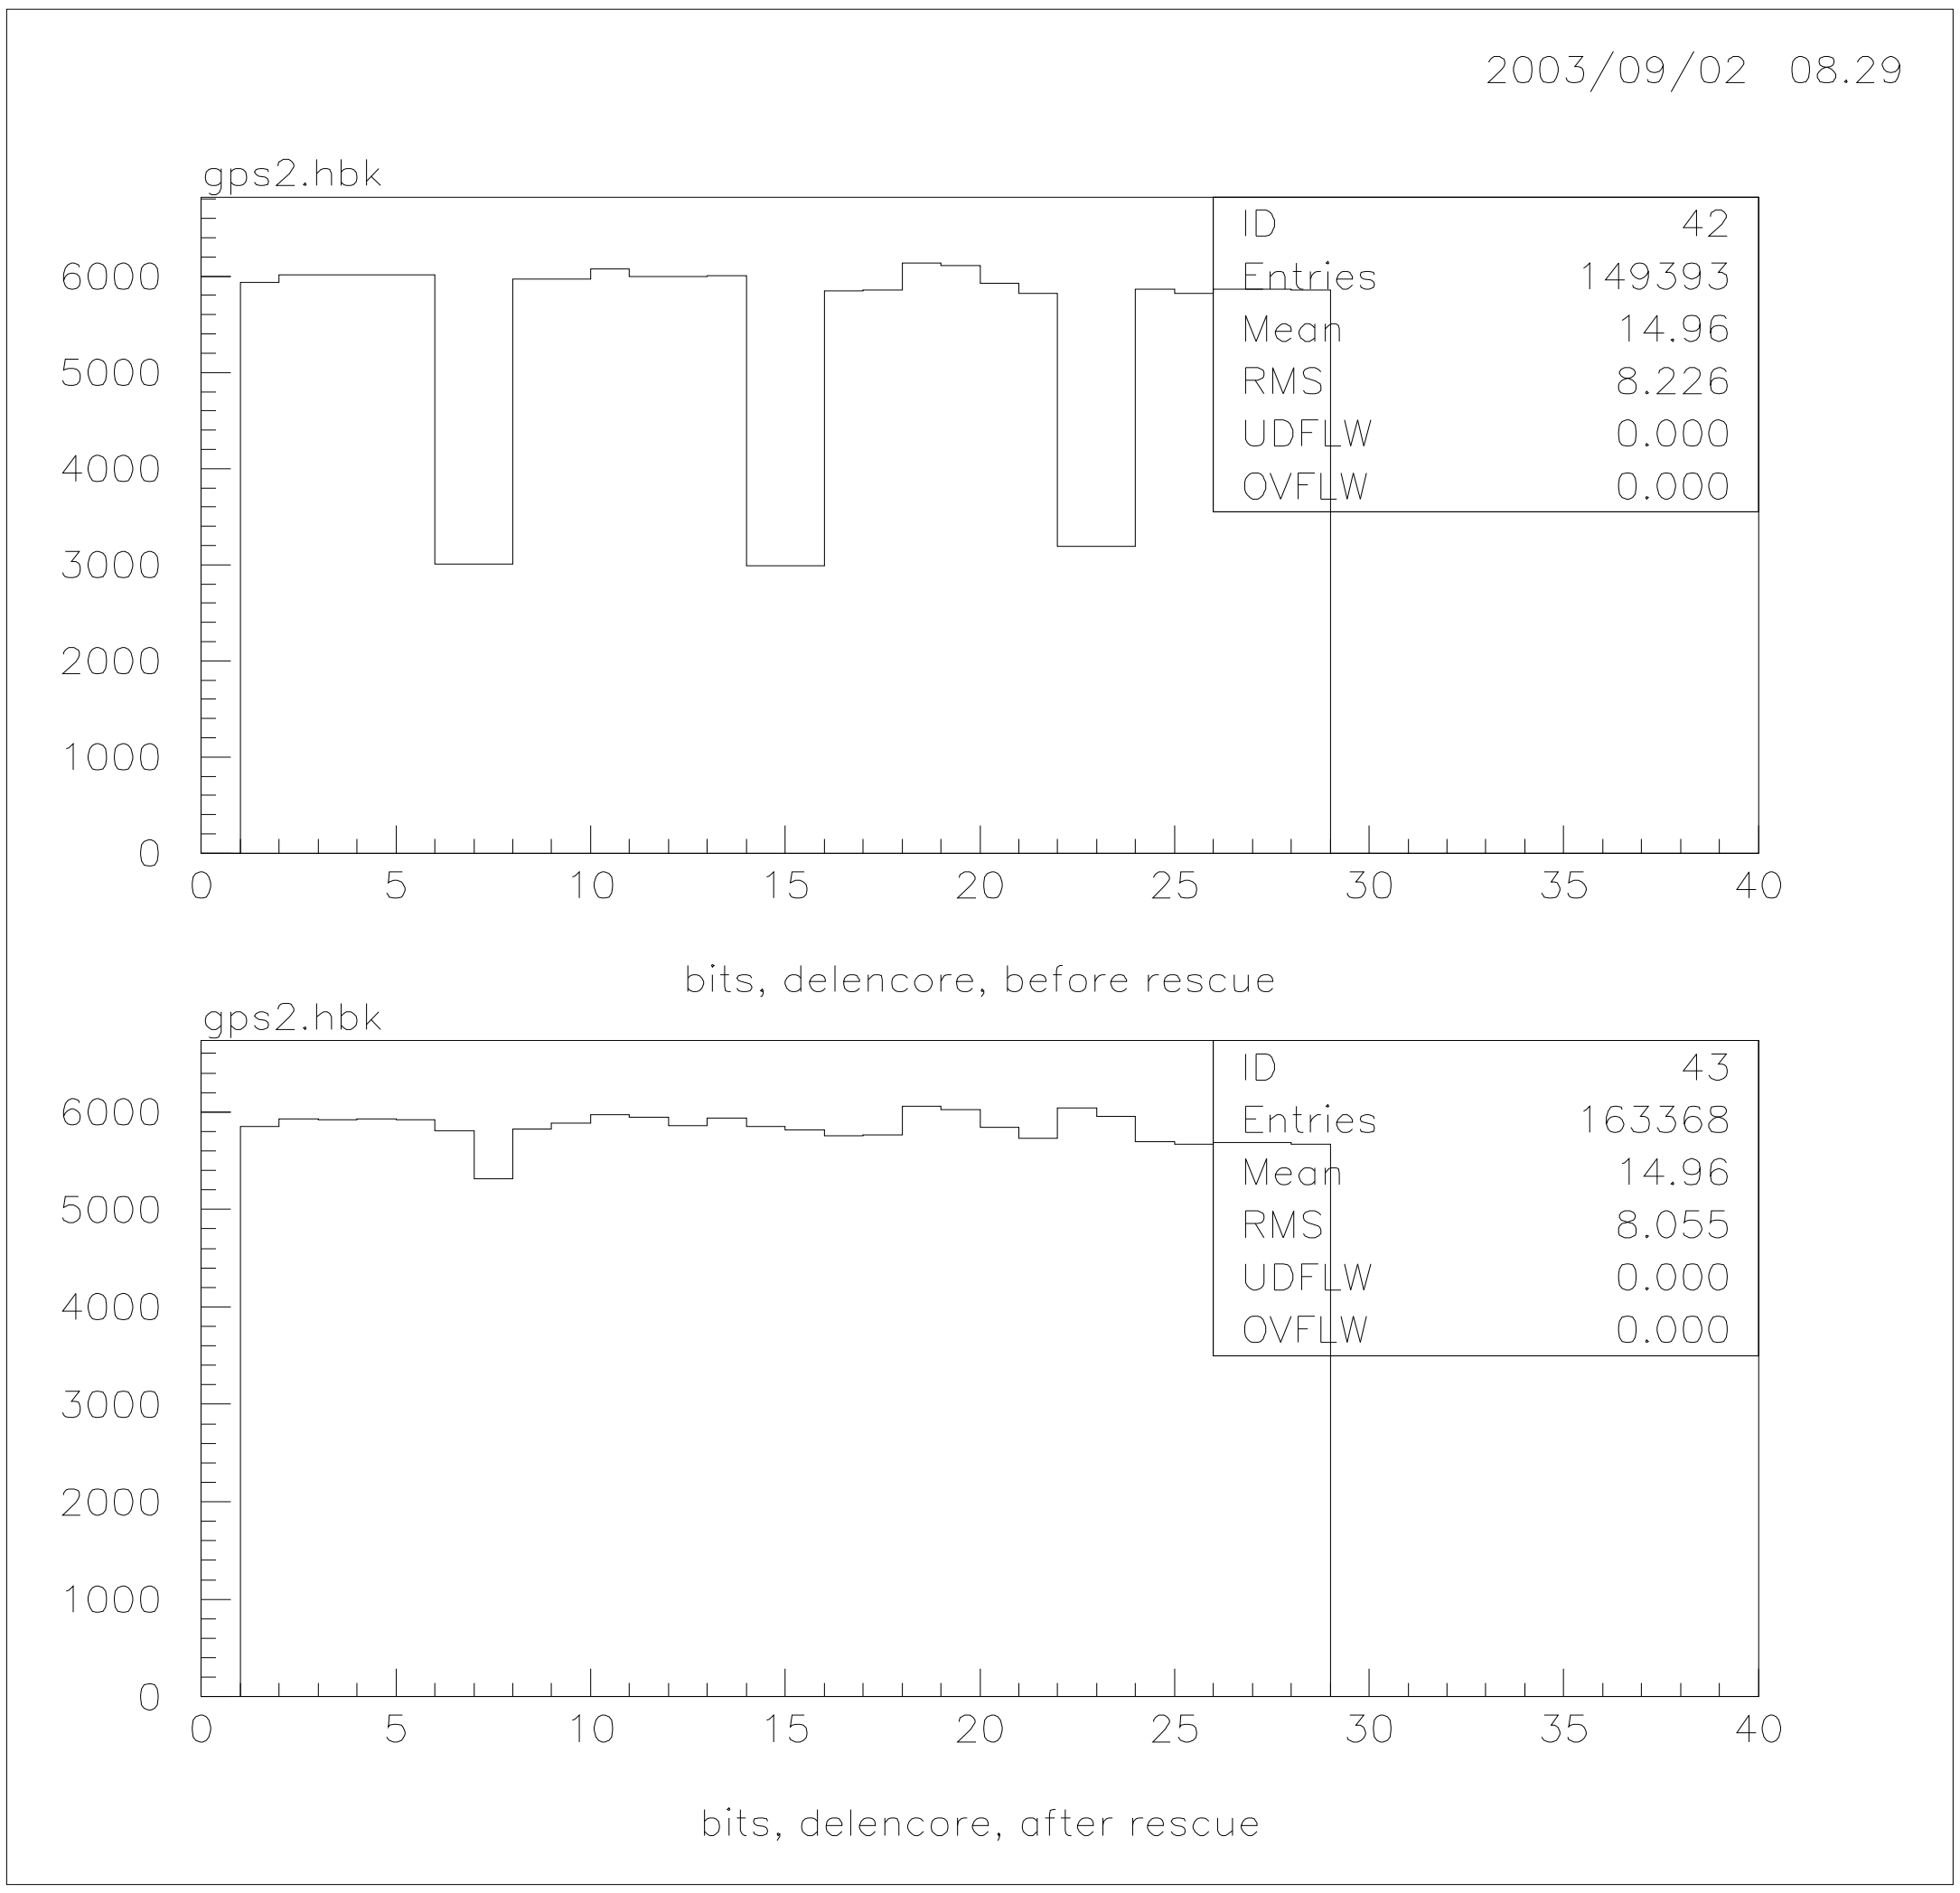
One problem which surfaced promptly was an apparent problem with missing bits. The problems appeared to be primarily in three pairs: (5,6), (13,14), (21,22), starting from bit 0 on the right, or lower end. The behavior appeared to be that if both should be there, both were. However, if one but not the other should be there, both were missing. If both should be missing, then both appeared to be missing. Routines were developed to correct for this error, in the current specialized case in which the event times should be reliably spaced either 1 clock count or 41,666,646 counts apart. If these times did not agree with expectations, both the input event time and the Fermilab one second GPS marker were treated as follows:

The improvement is evident, although clearly some problems remain. There are undoubtedly remaining low level flaws in our bit corrections, but we judge that the bit correction is adequate to proceed, since it now gives no errors at more than 100 counts for the difference between two event times from the Oncore gps. And it is not useful to strain to correct the bits from the difference between the two Oncore gps time, since in general the Oncore gps time will not be available as a second marker, and even if it were, it would not come at the same time as the Fermilab board one second marker, and so the procedure used here could not be used to get reliable time differences between the event time and the one second marker. Clearly the missing bit problems must be solved before the board can be used in its intended application.

Figure 2: Bit occupancy patterns before (above) and after (below) the bit-rescue operation was applied.

1. Either 2^{n1} or 2^{n2} (where $2^{n2} = 2\times^{n1}$ is added to the second event time, to make the difference closer either to 1 count (for a continuing event) or 41,666,646 counts (1 sec). The algorithm used is that if the event time differences were different by an amount which indicated that either bit (of the pair (n1,n2) might be missing, then 2^{n1} was added. This will shift the ones with the missing n1 bit into agreement and the ones with the missing n2 bit into the missing n1 bit position. The test (and correction, again both using 2^{n1}) were then repeated. In this way either 2^{n1} or 2^{n2} would be added (to both the event time and the Fermilab one second marker).

2. If the difference is higher than expected, by an amount which corresponds to the flaky bits, then 2^{n1} or 2^{n2} are subtracted from the event time. In principle, if the bits are always missing, this second step should not be required. However, an attempt to avoid it led to failures to fix the bits correctly. This could be due either to the possibility that an initial event had the bits mis-set, or that the bits in some cases were actually present when they should not be. We have not attempted to distinguish between these two possibilties, but simply gone ahead and allowed an adjustment either upward or downward corresponding to the troublesome bits. But in examination of individual events (without following the chain through completely) we did not find any instance in which the bits were erroneously present.

3. The procedure above was applied first for the (21,22) pair, then the (13,14) pair, and then the (5,6) pair. Figure 2 shows a histogram of occupied bits for all event times, before and after the corrections were applied.

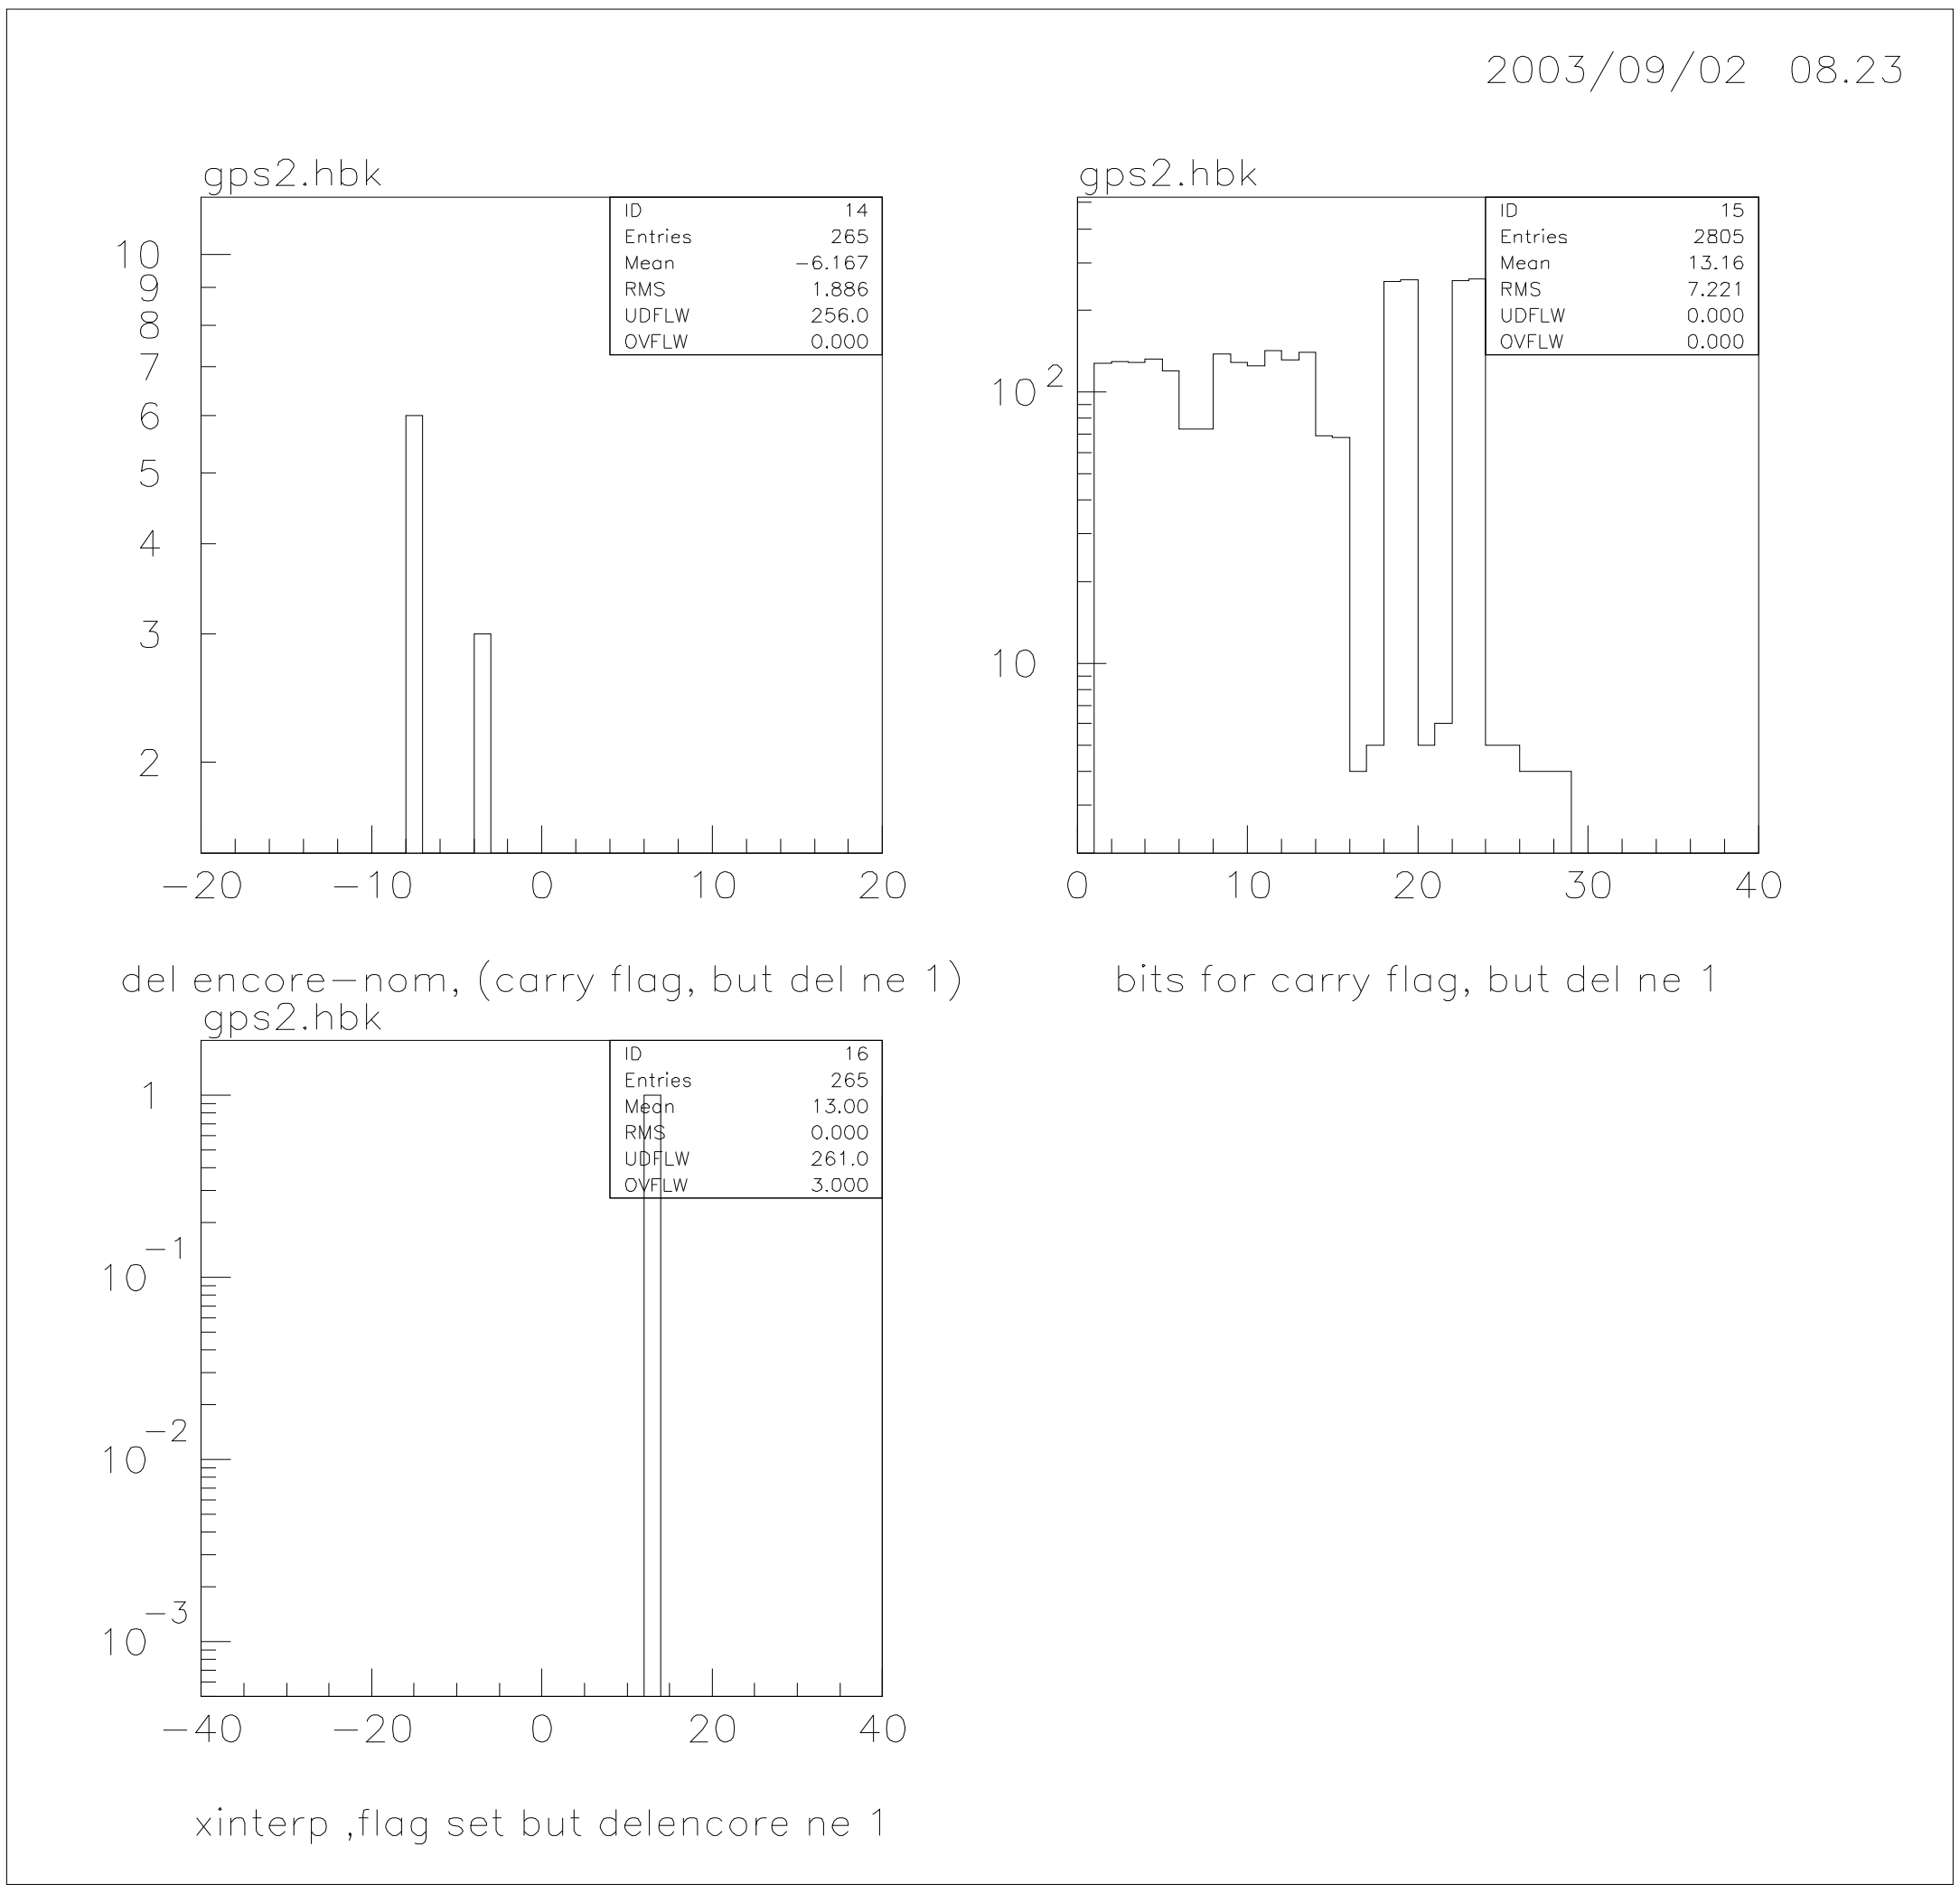
Of 4151 events which had the event time (the Motorola GPS 1 sec marker pulses) differing by 1 clock count (indicating an event which carried over from one clock pulse to the next), all events had the 2 bit set in the error flag. Of the 265 events which had the carry bit set but did not have two event times differening by 1, 9 differed by 41.6Mhs and the rest had values differing by more than 20 from the last verified good event pulse. We have not studied all of these. 151 of them come from one spate of difficulty in which nonsense values of were appearing in the Oncore times. (upper left in Figure 3. Another indication of a problem is the difference between the event times and the fermilab time vs line in the input file shown in Figure 4. Most of the serious disagreements seem to be concentrated in a rather narrow range of data.

Figure 3: Events for which the difference between two successive event times (Motorola GPS) was not 1, although the "continuation flag bit" was set. Upper left: Difference between successive event times; upper right: bit occupancy patterns for the event time; lower left: difference between the event time and the Fermilab one second marker time

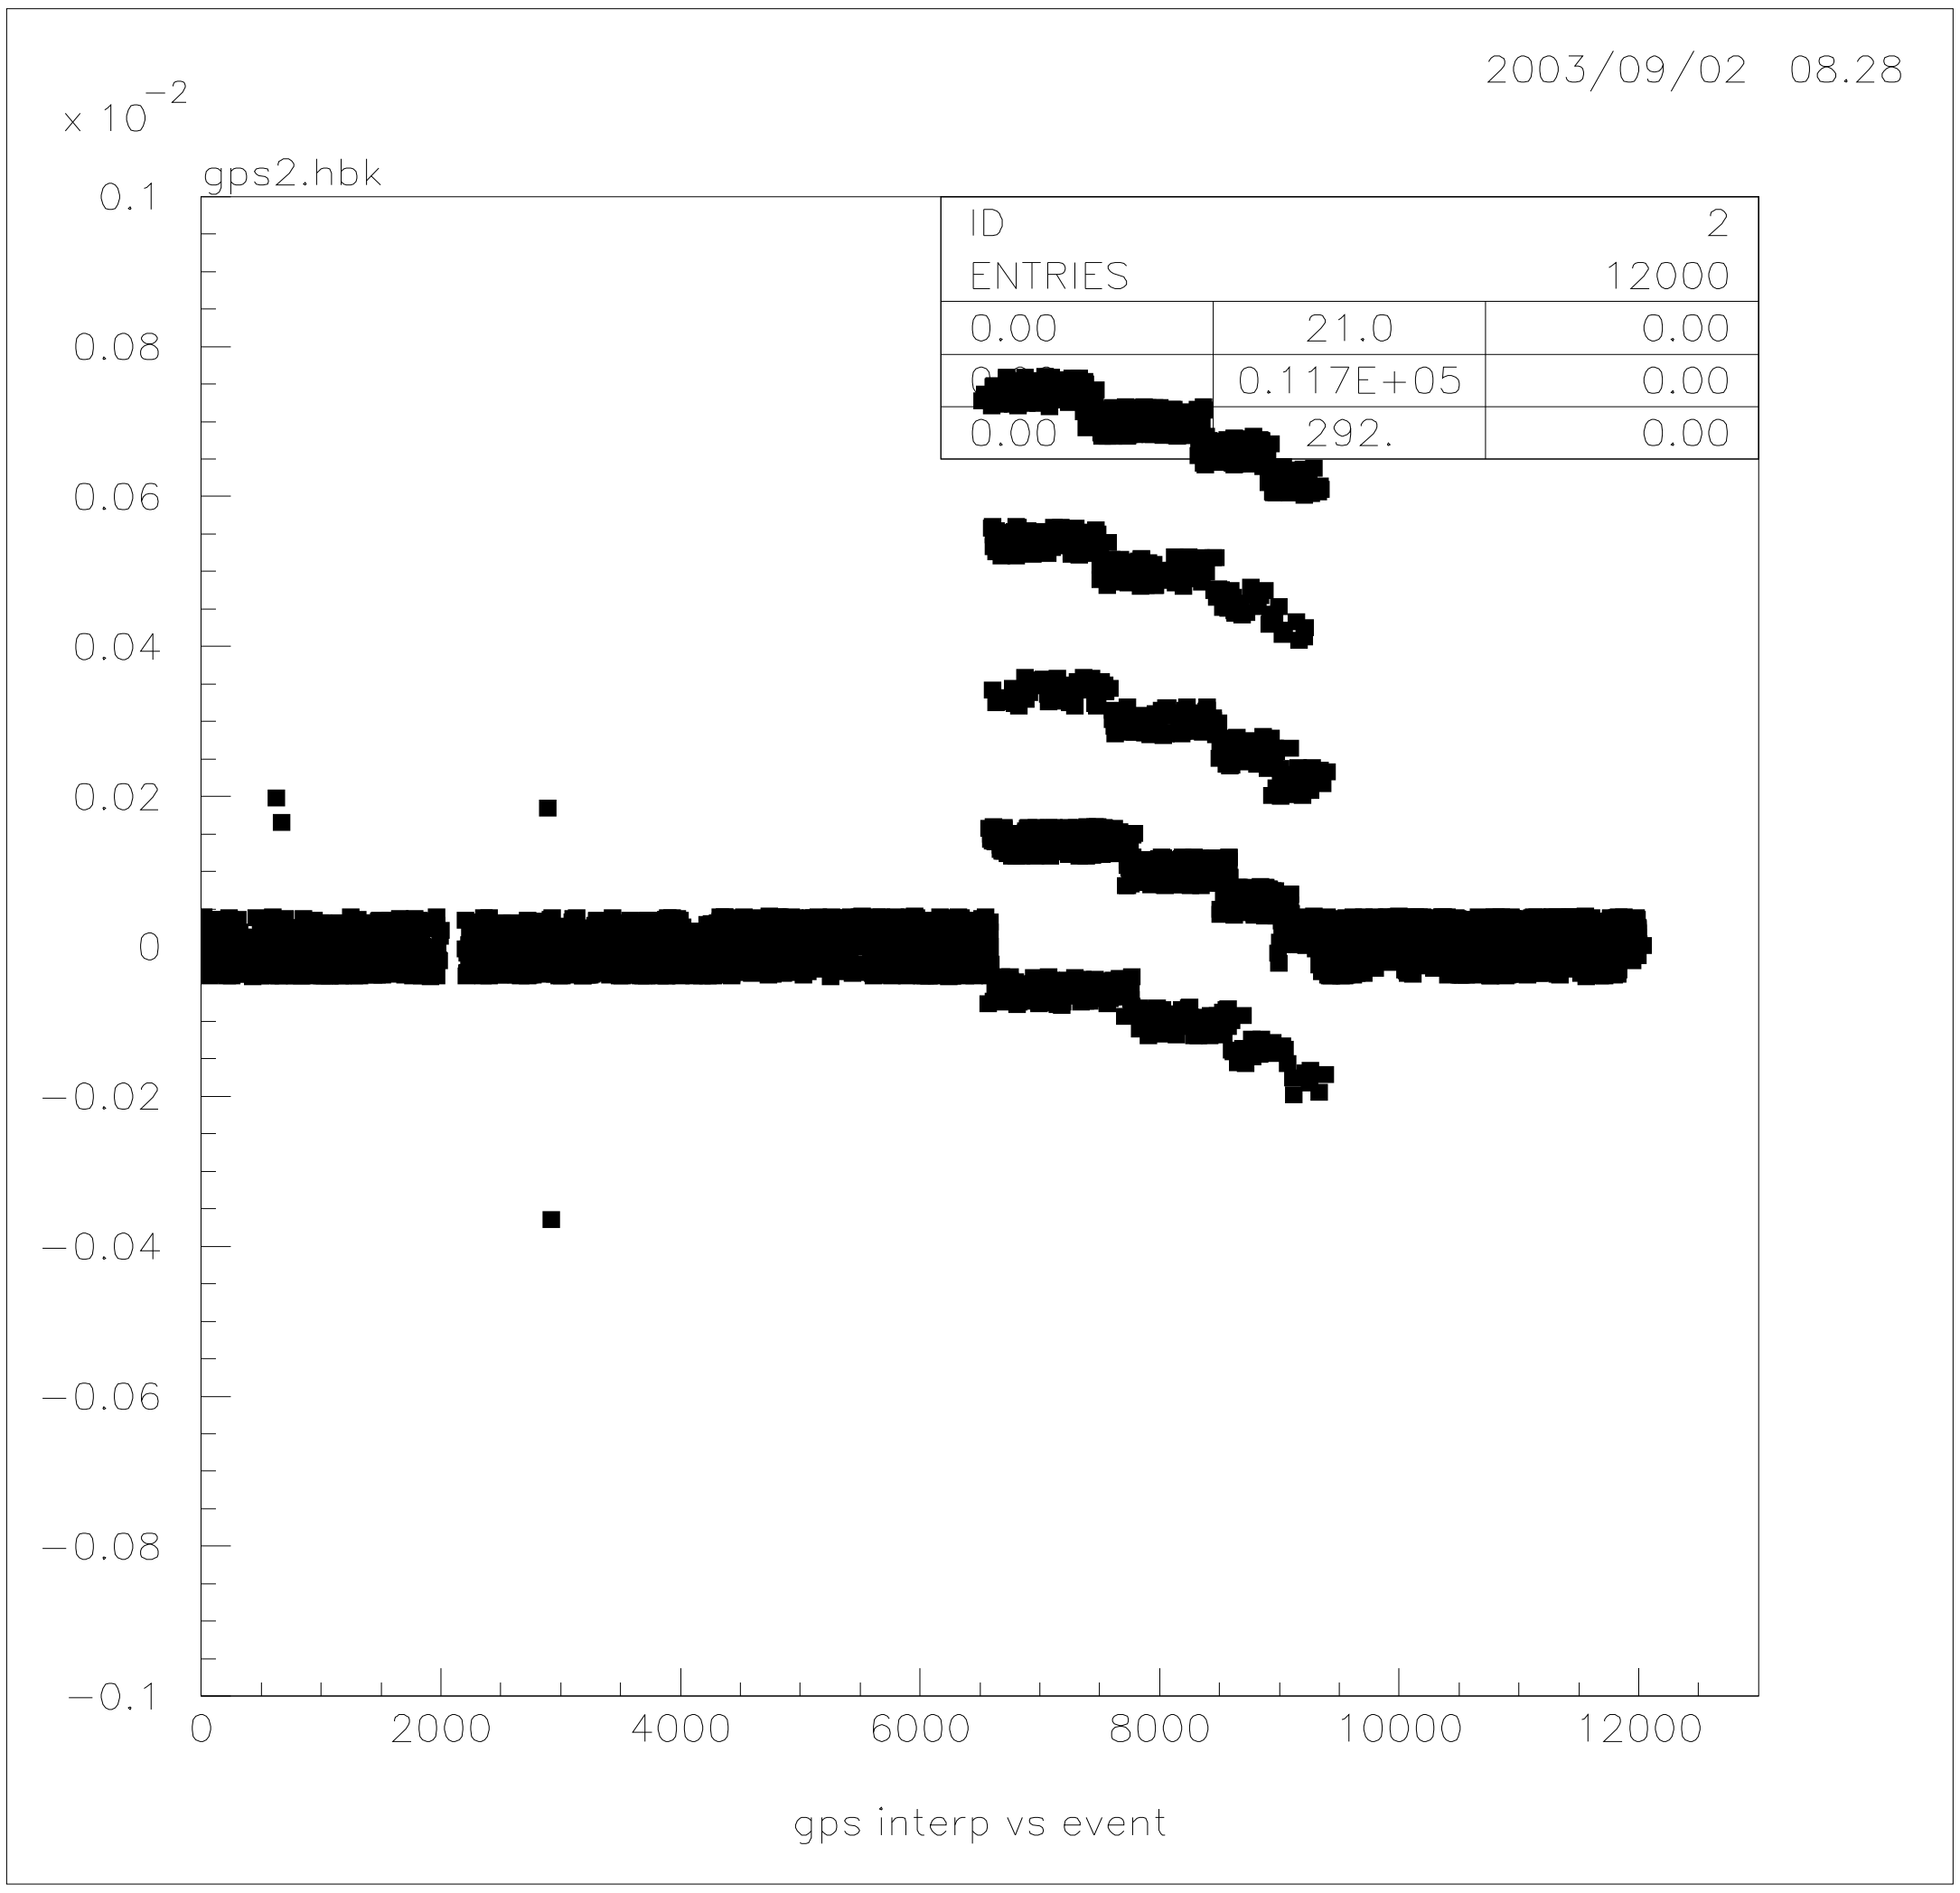
Figure 4: Difference (in seconds) between the Motorola GPS time and the FNAL board GPS one second time marker, as a function of record sequence number in the data file.

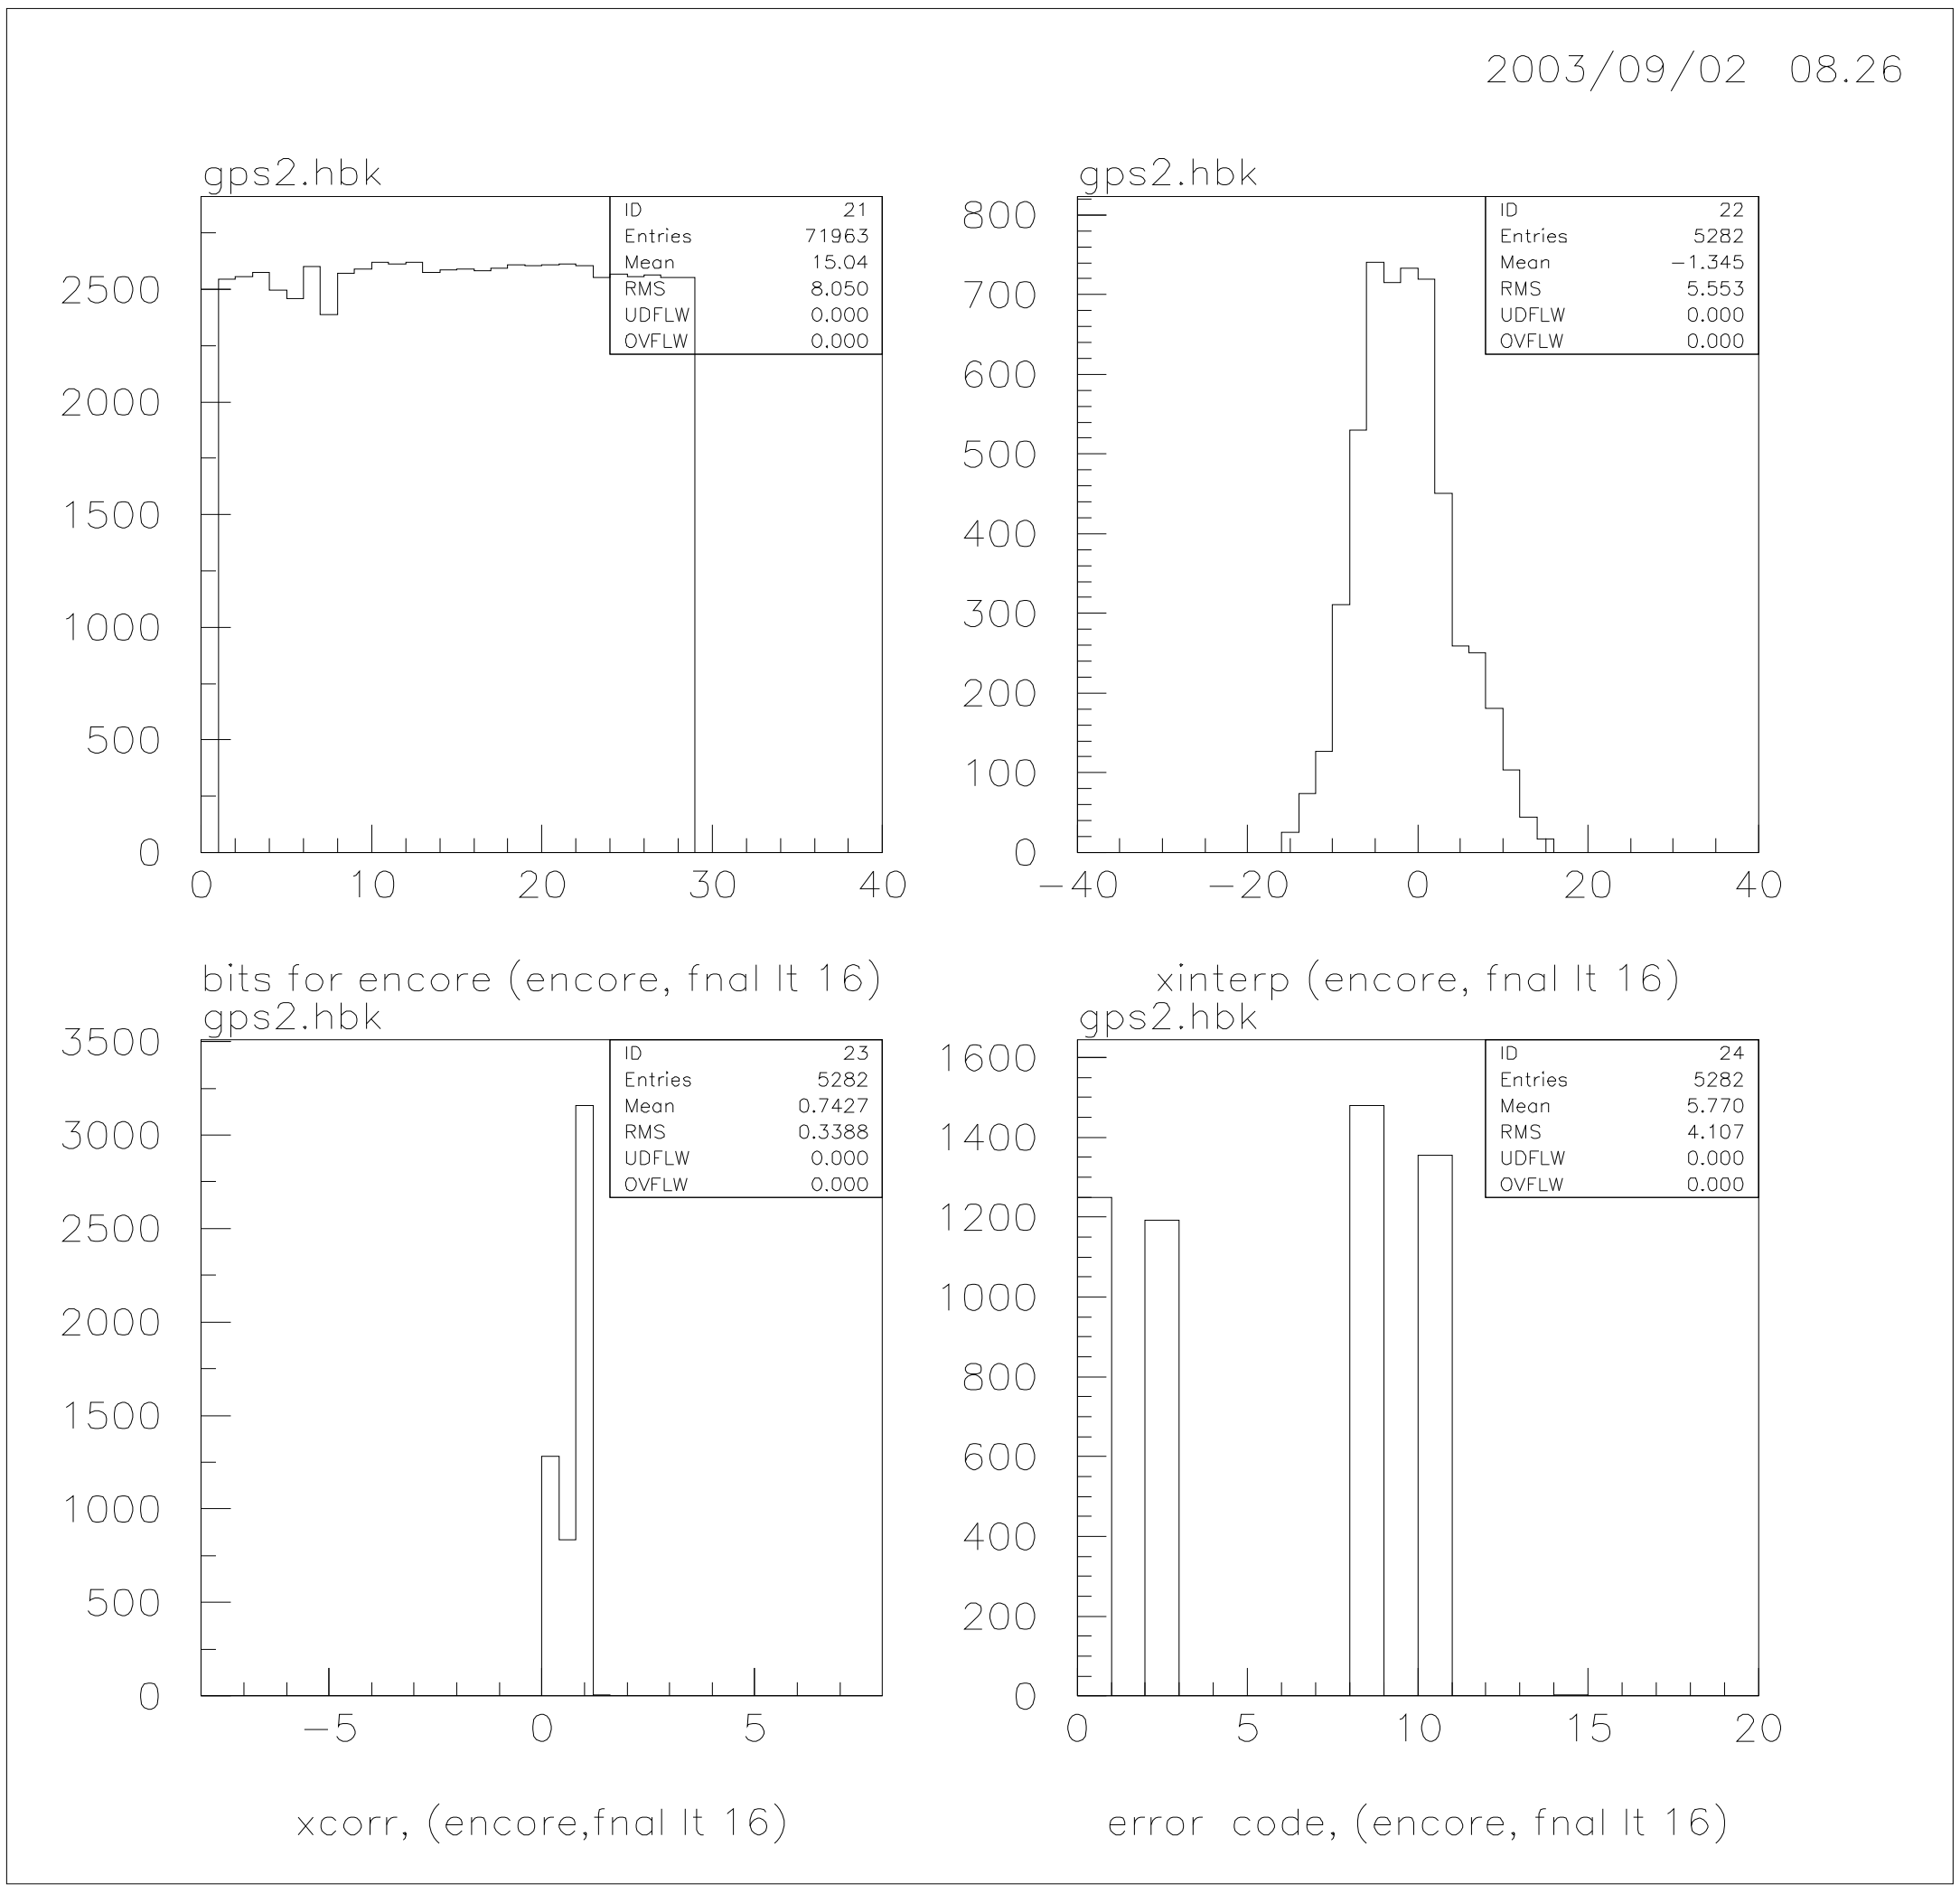
Figures 5 and 6 show relevant distributions for the two samples in which the Motorola differs from the fnal gps time by less than (or more than) 16 counts. The bit patterns are reasonably flat in both groups. The "xinterp" plot is the Motorola - fnal times, in counts. Since a count is $[1/(41.666646\ \mathrm{M})]$ sec, the sigma of 6 for the less than 16 count sample implies a precision, at this point, with known problems removed, of about 100 nsec. The structure in the similar plot for the sample with bigger differences than 16 indicates some remaining bit-swapping problems. The xcorr plot shows the correction to the crude fnal board gps second time, from the board's own calculation. The negative xcorr values are shown in the section on synchronicity to be connected with time keeping glitches between the motorola and the fnal gps times.

Figure 5: Plots of various quantities for the sample in which the Oncore time and the Fnal one second GPS time differ by less than 16 counts. Upper left: frequency of bits set (bit occupancy pattern); ;upper right: difference between Motorola and Fnal GPS time values; lower left: the correction to the crude one second (Fnal) GPS time in the record; and lower right: the error flags for these events.
