Tests of FNAL GPS Coincidence Board

David E. Kraus, Gene Bender, Steve Grosland, Julia Thompson
UMSL/PITT Quarknet/RET 2003

September 4, 2003

Tests performed on the Fermilab Quarknet Board in summer 2003 at the Pitt/UMSL Quarknet/RET program are described. Problems and workarounds are discussed.

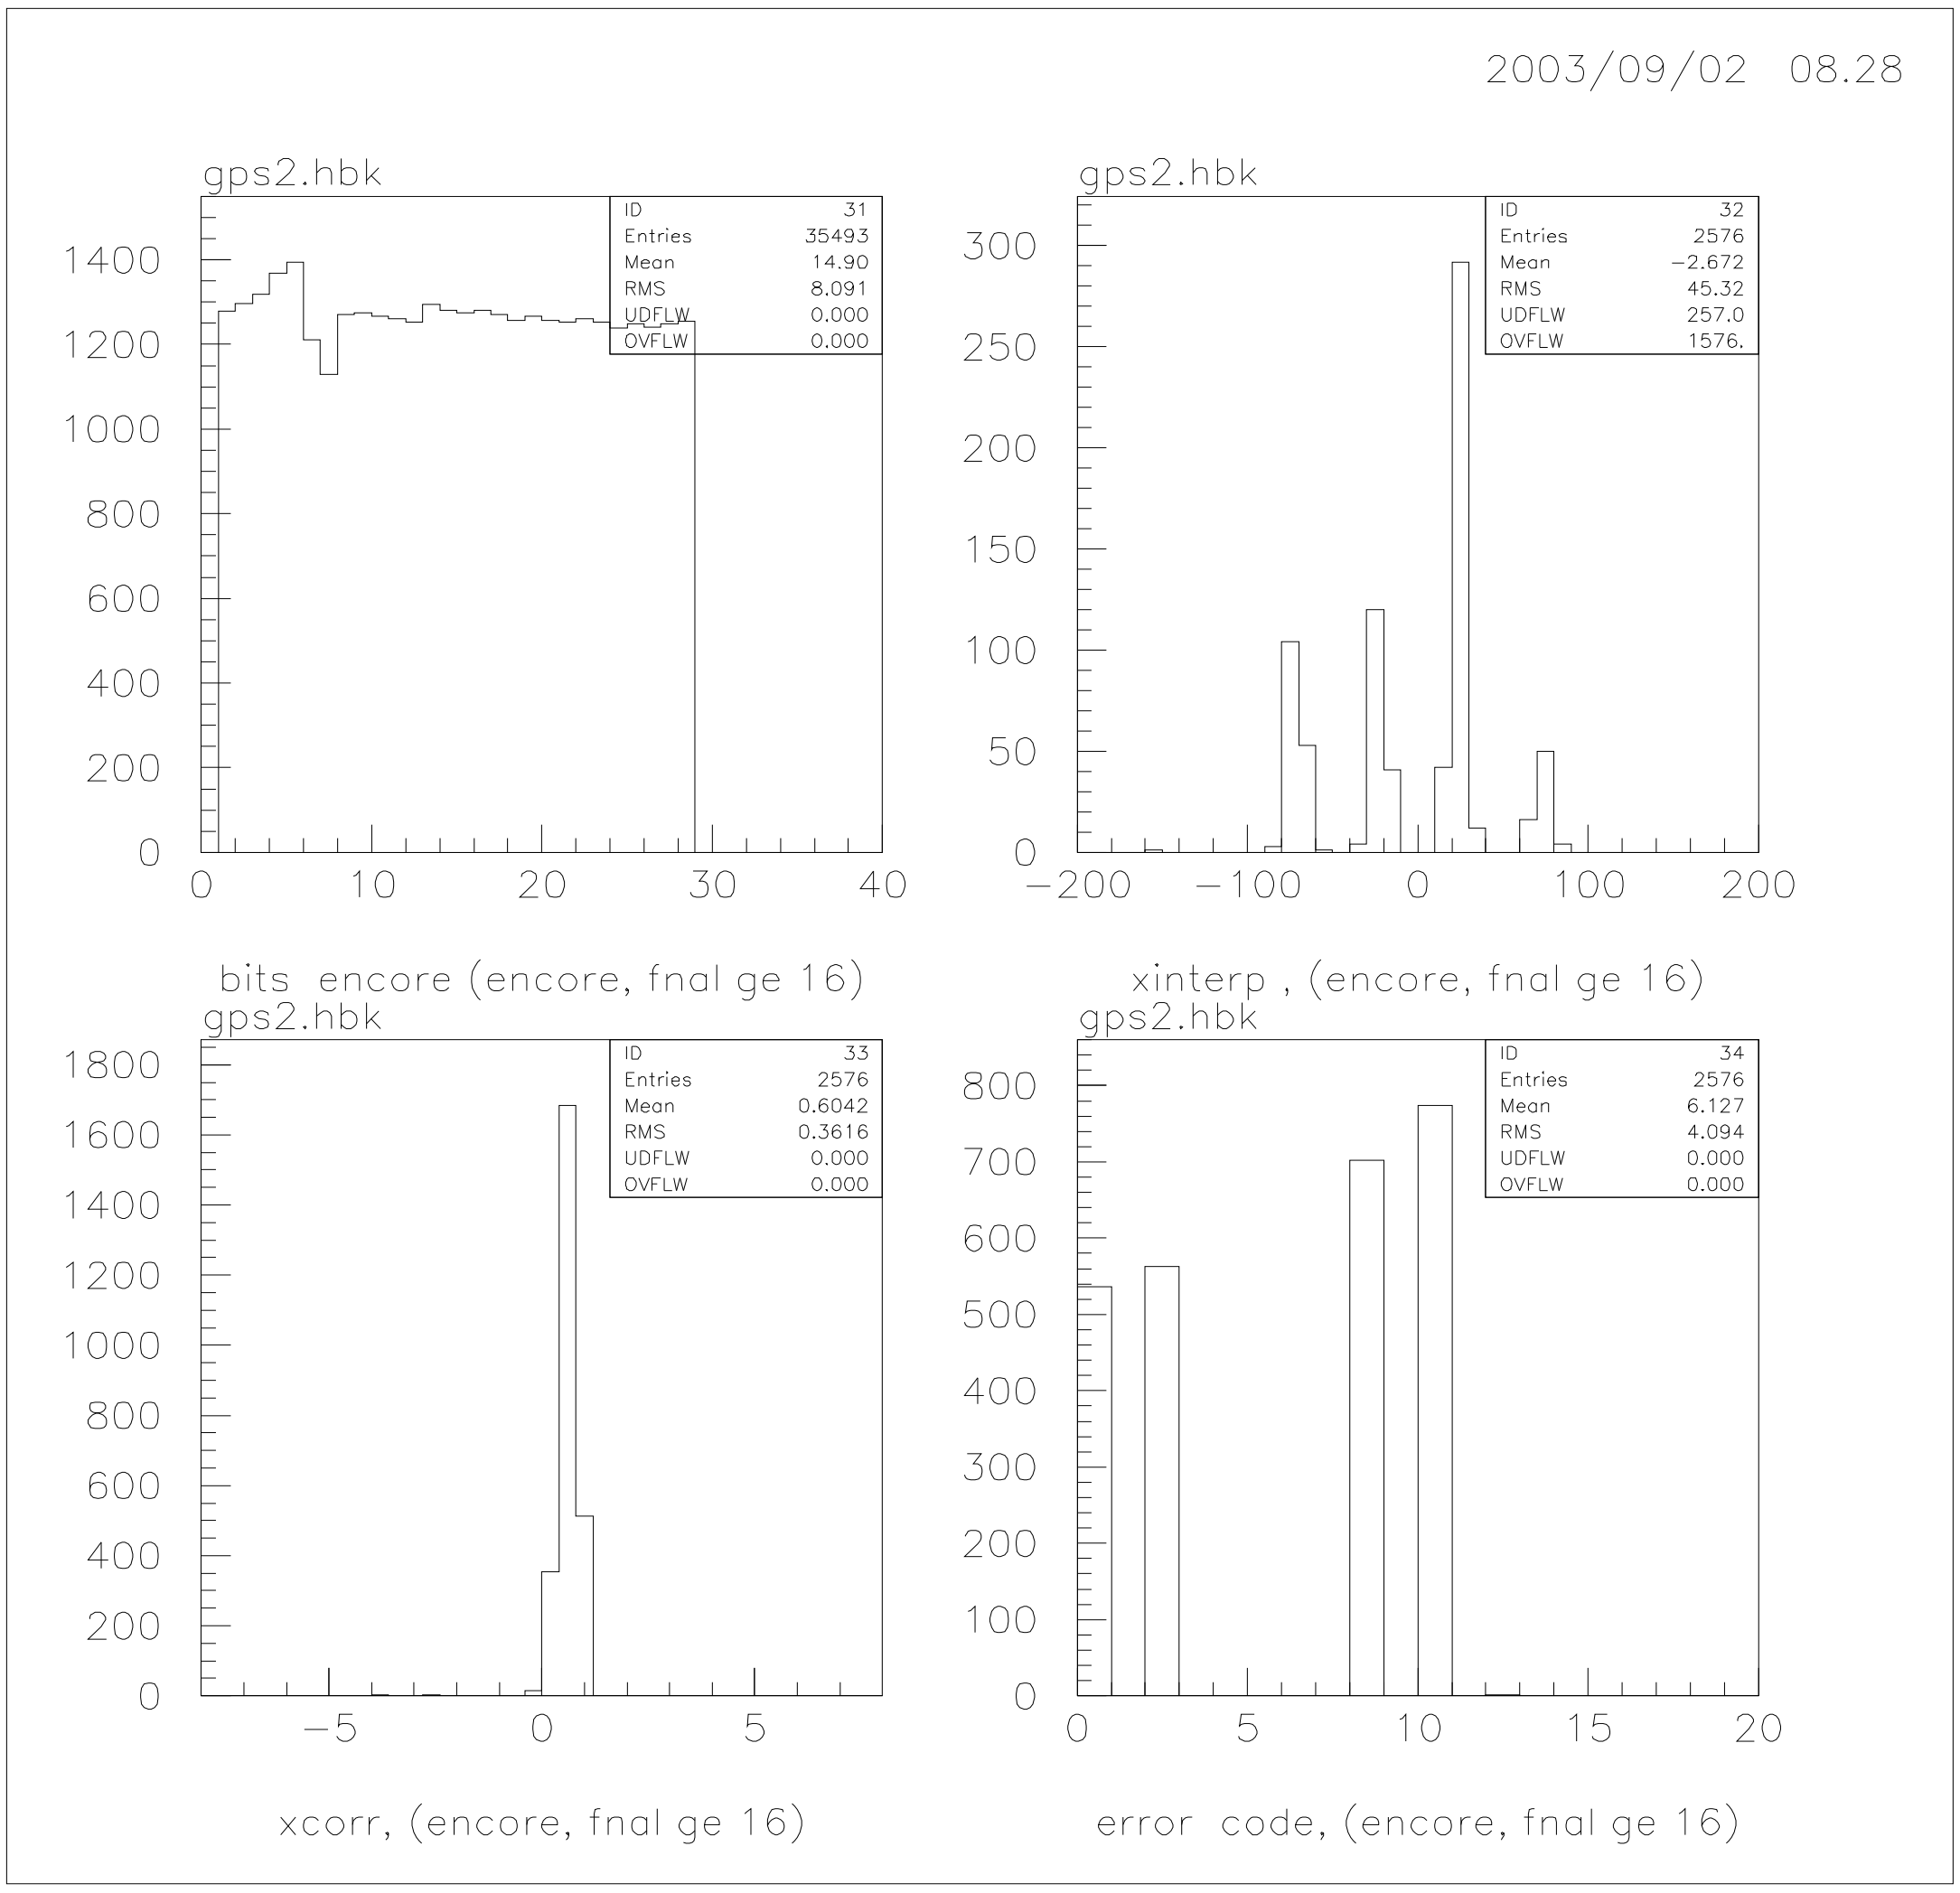
Figures 5 and 6 show relevant distributions for the two samples in which the Motorola differs from the fnal gps time by less than (or more than) 16 counts. The bit patterns are reasonably flat in both groups. The "xinterp" plot is the Motorola - fnal times, in counts. Since a count is $[1/(41.666646\ \mathrm{M})]$ sec, the sigma of 6 for the less than 16 count sample implies a precision, at this point, with known problems removed, of about 100 nsec. The structure in the similar plot for the sample with bigger differences than 16 indicates some remaining bit-swapping problems. The xcorr plot shows the correction to the crude fnal board gps second time, from the board's own calculation. The negative xcorr values are shown in the section on synchronicity to be connected with time keeping glitches between the motorola and the fnal gps times.

Figure 6: Events with the gps and fermilab times differing by more than 16 counts: Plots of various quantities (Upper left: bit frequency pattern; upper right: difference between Motorola and Fnal GPS time values; Lower left: the correction to the crude one second (Fnal) GPS time in the record; lower right: error flags for these events.

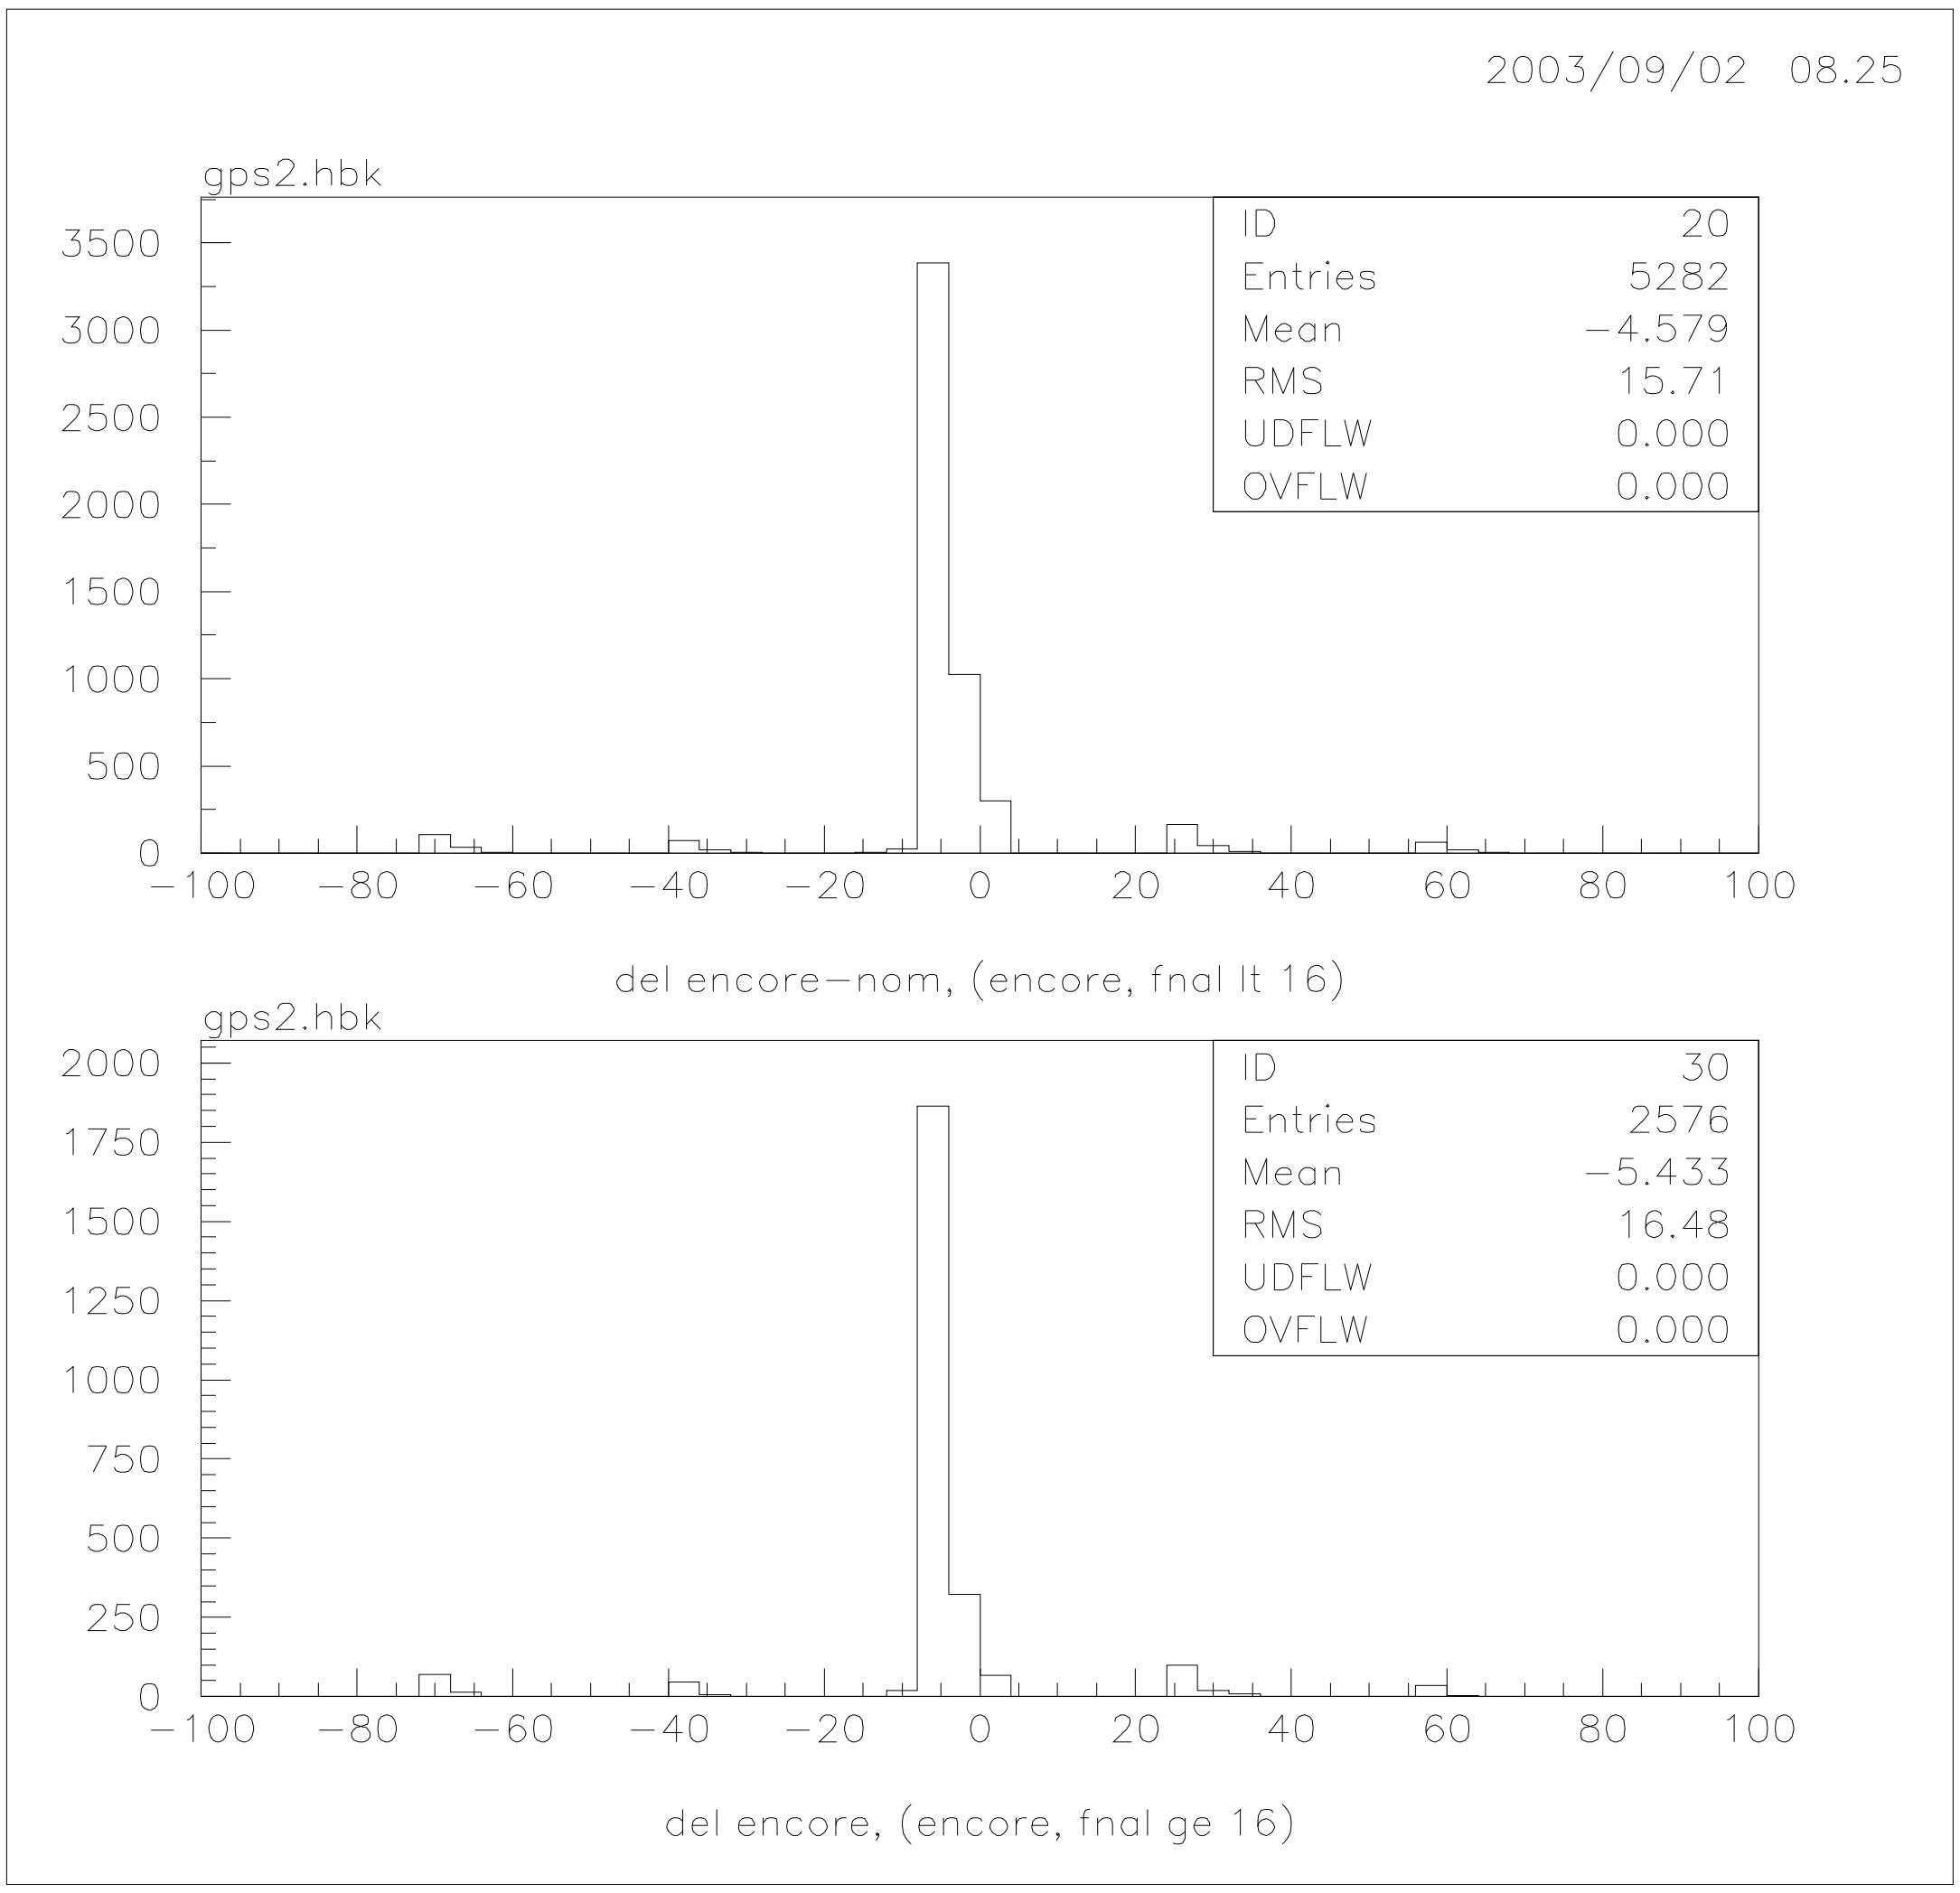
Figure 7 shows the difference in Motorola Oncore event times for the two samples. The discrete distributions to each side of the main peak were not present until the events missing an overflow bit were rescued. (Previously they were outside the histogram). The structure is indicative of some remaining bit-swapping problems for events in which the high order bits roll over. Again, due to time constraints, this was not thoroughly investigated, but may be due to imperfections in the algorithm used for these cases.

Figure 7: Difference between successive Motorola - Oncore pulses (with the nominal value of 41,666,646 subtracted). The difference is shown for the two samples: Motorola - fnal greater and less than 16 counts). Note that the variable in the FORTRAN program was erroneously spelled delencore rather than deloncore.

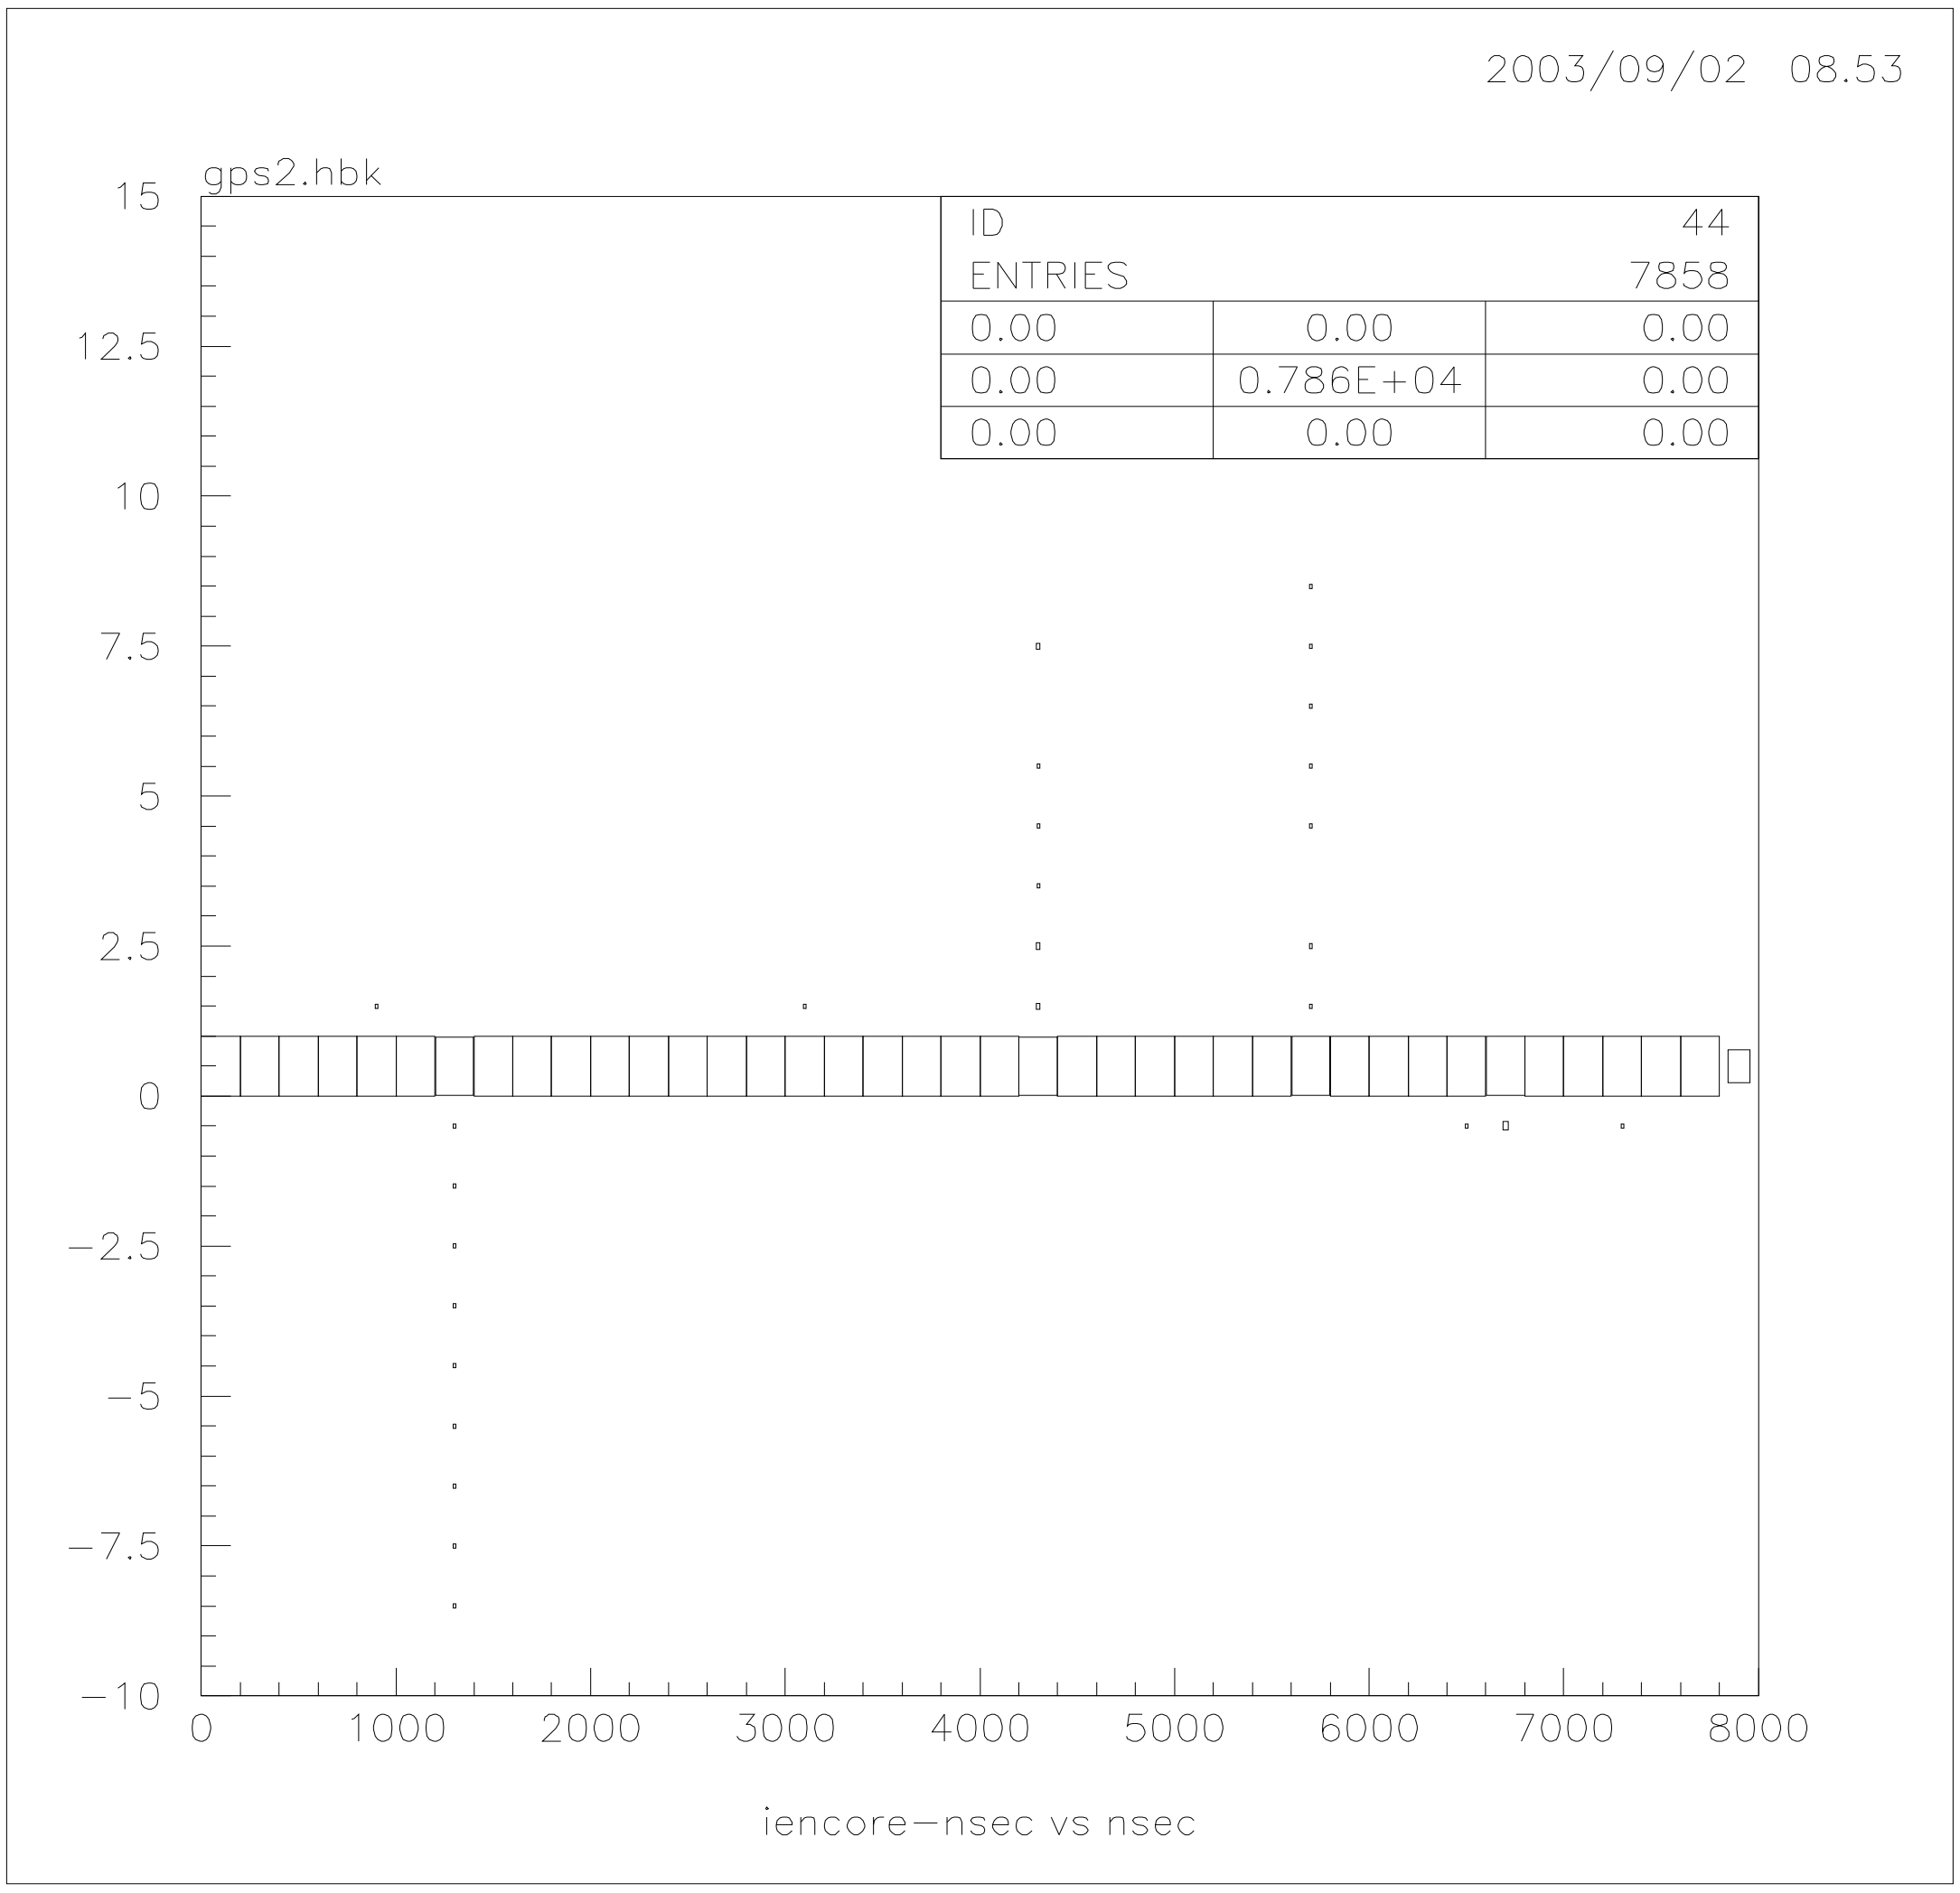
The two numbers agree. The correspondence runs off in some cases, but is relatively quickly restored, as shown in Figure 8, and discussed in the following subsection.

Figure 8: Difference between the Oncore event number (inferred by taking successive Motorola - Oncore pulses within 100 counts of the nominal value of 41,666,646) and the expected number of events inferred from the fnal board crude hour/min/time value provided. With some excursions during times when the crude time marker was clearly misbehaving, the two event markers agree exactly over most of the run.
